Service Update

17106 Windshield Wiper Transmission Missing Welds

Reference Number: N172088650

Release Date: March 2017

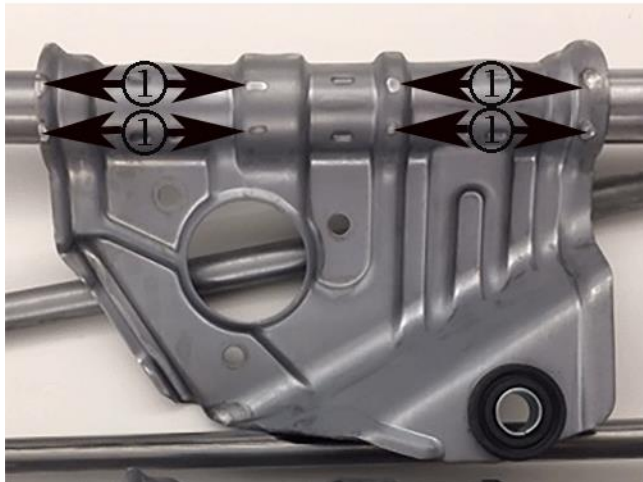
4738923

Unacceptable condition

- If the four raised portions of the motor bracket displays any weld tip contact (1), proceed to step 3 below.

- If the four raised portions of the motor bracket are free of any weld marks (2), then proceed to step 4.
3. Replace the windshield wiper transmission. Refer to *Windshield Wiper Transmission Replacement (Chevrolet/GMC)* in SI.
 4. Reinstall the wiper arms and air inlet grill panel. Refer to *Air Inlet Grille Panel Replacement (Chevrolet/GMC)* in SI.

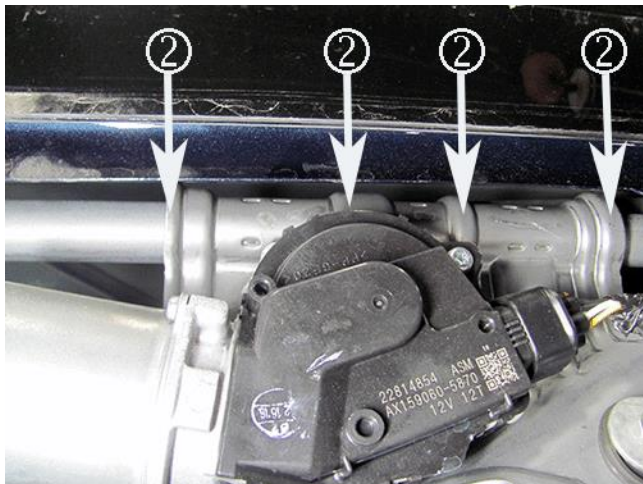
4738928

Correctly welded part
