Service Update

17145 Power Transfer Unit Vent Hose Routing

Reference Number: N172089080

Release Date: March 2017
Revision: 00

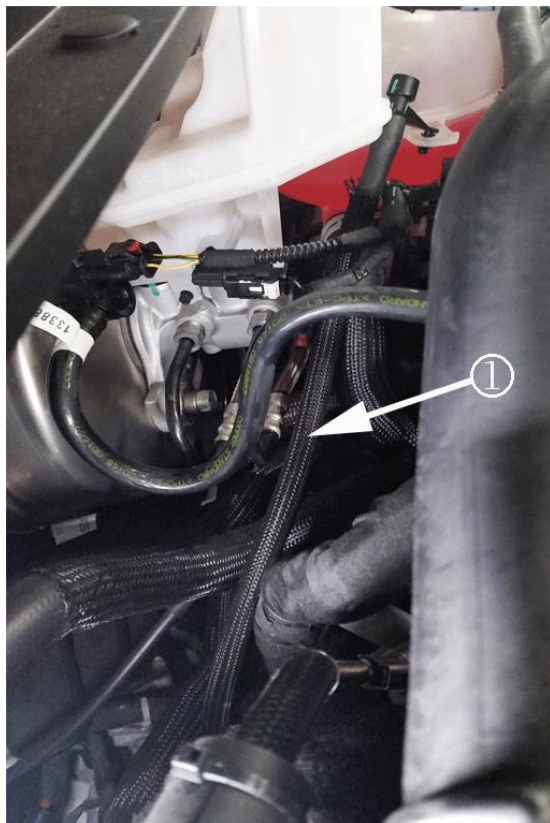
4757692

2. Locate the power transfer unit (PTU) vent hose (1).

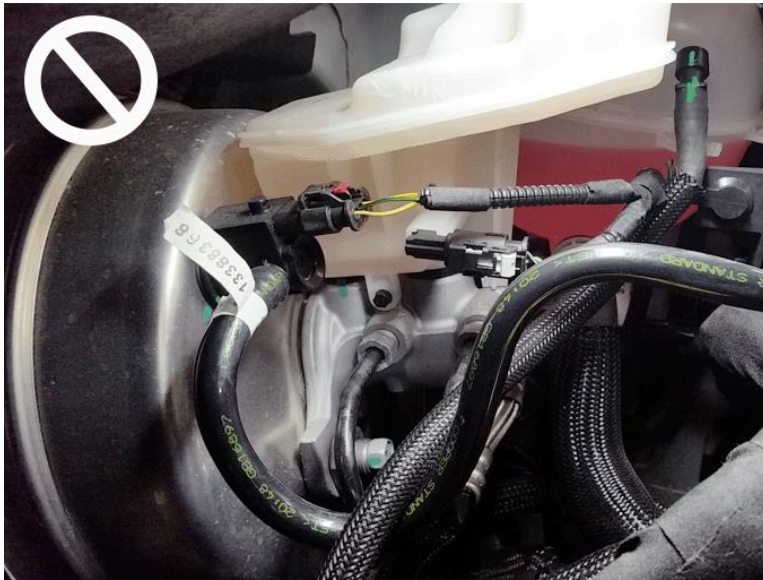
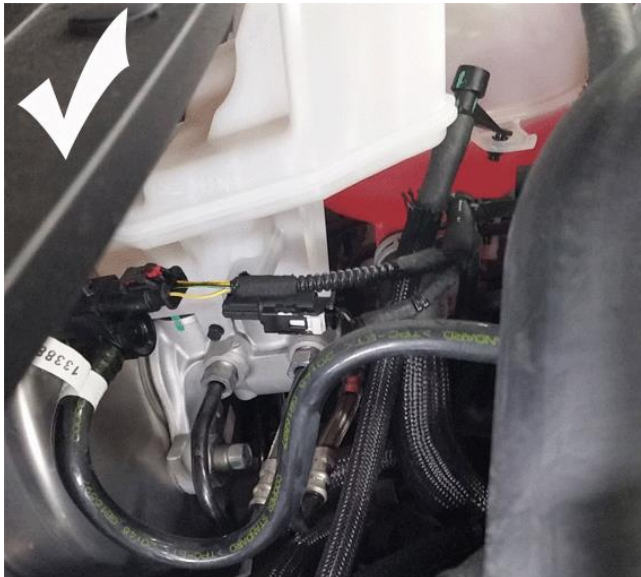
3. Verify the PTU vent hose is routed properly.
 - If the PTU vent hose is routed properly, no further action is required.
 - If the PTU vent hose is NOT routed properly, inspect the power brake booster vacuum pipe for damage.
 - If the power brake booster vacuum pipe is NOT damaged, proceed to the next step.
 - If the power brake booster vacuum pipe is damaged, replace the power brake booster vacuum pipe and proceed to the next step. Refer to *Power Brake Booster Vacuum Pipe Replacement (LYX)* in SI.
