# Service Update

## 17146 Vacuum Pipe Routed Under Brake Lines

Reference Number: N172089110

Release Date: March 2017  
Revision: 00

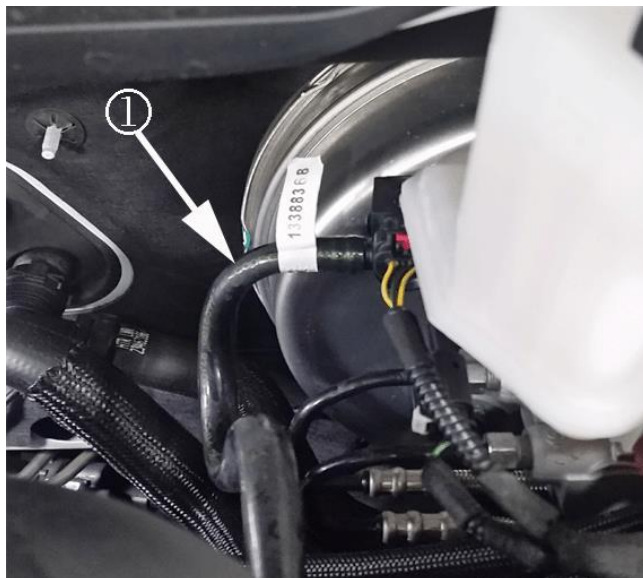
4757626

2. Locate the power brake booster vacuum pipe (1).

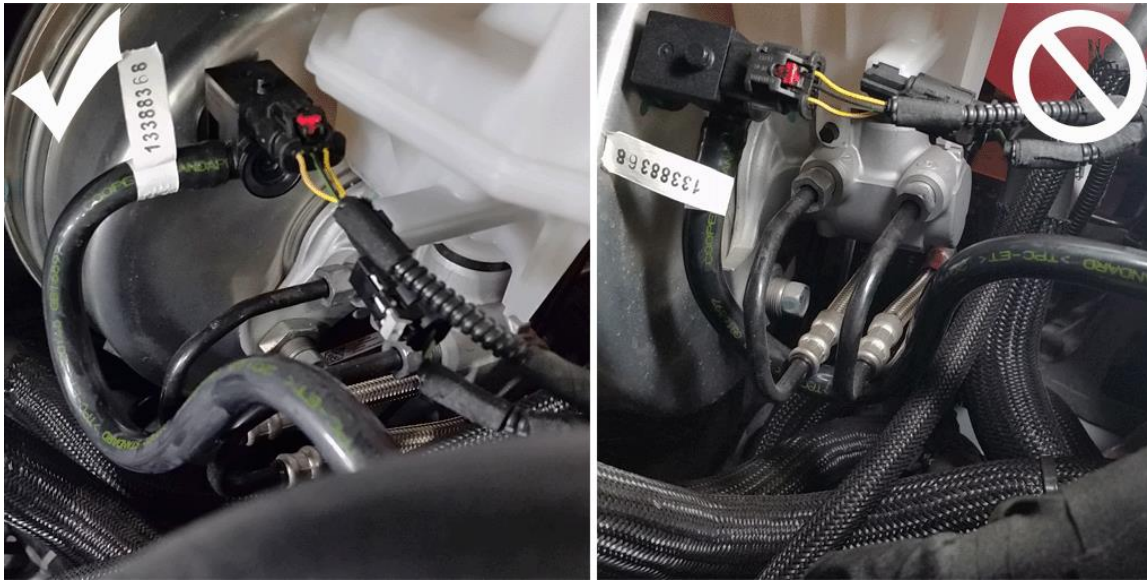
4757629

3. Verify the power brake booster vacuum pipe is NOT contacting the brake lines and is routed properly.
  - If the power brake booster vacuum pipe is NOT contacting the brake lines and is routed properly, no further action is required.
  - If the power brake booster vacuum pipe is contacting the brake lines or is NOT routed properly, inspect the power brake booster vacuum pipe for damage.
    - If the power brake booster vacuum pipe is NOT damaged, proceed to the next step.
    - If the power brake booster vacuum pipe is damaged, replace the power brake booster vacuum pipe and proceed to the next step. Refer to *Power Brake Booster Vacuum Pipe Replacement (LYX)* in SI.
