Service Update

17145 Power Transfer Unit Vent Hose Routing

Reference Number: N172089080

Release Date: March 2017
Revision: 00

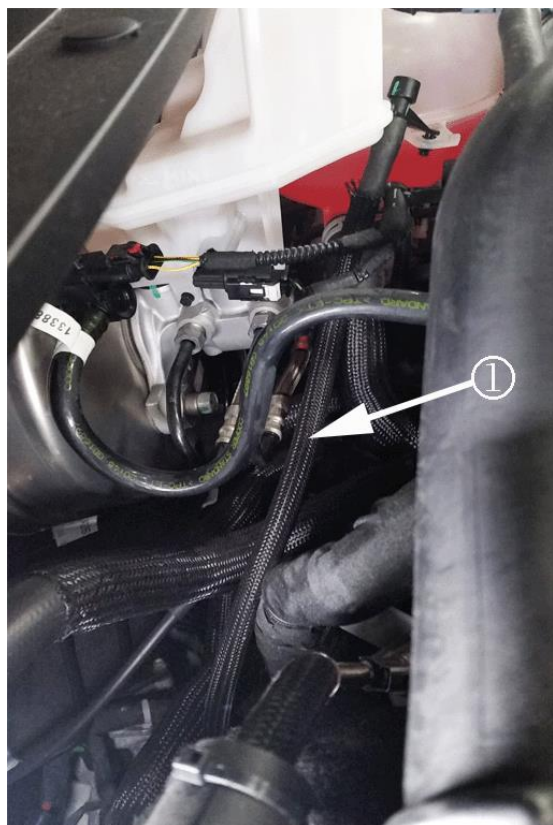
4757692

2. Locate the power transfer unit (PTU) vent hose (1).

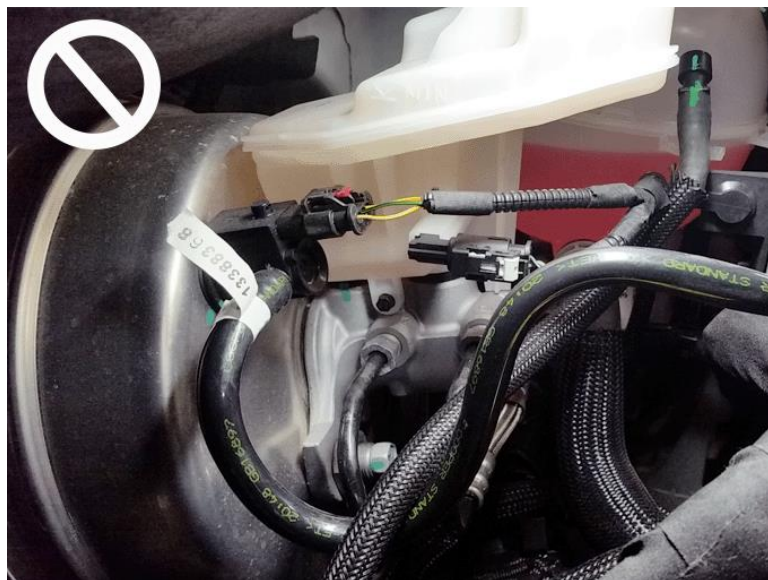
4757696

3. Verify the PTU vent hose is routed properly.
 - If the PTU vent hose is routed properly, no further action is required.
 - If the PTU vent hose is NOT routed properly, inspect the power brake booster vacuum pipe for damage.
 - If the power brake booster vacuum pipe is NOT damaged, proceed to the next step.
 - If the power brake booster vacuum pipe is damaged, replace the power brake booster vacuum pipe and proceed to the next step. Refer to *Power Brake Booster Vacuum Pipe Replacement (LYX)* in SI.
