## **Customer Satisfaction Program**

# 17137 Battery Negative Cable Nut Under-Torqued

Reference Number: N172083050 Release Date: March 2017

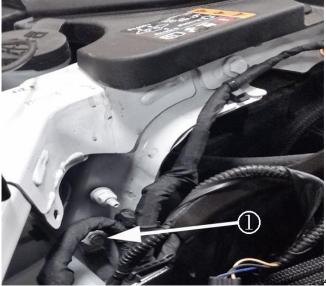
4758119

Condition	Certain 2017 model year Cadillac XT5 and GMC Acadia vehicles may have a condition in which the battery negative cable nut is under-torqued. In rare occurrences, this may lead to an increased potential for erratic, intermittent electrical symptoms including: door lock cycling, instrument cluster inoperative, unwanted downshifts, loss of radio display and audio, illumination of malfunction indicator lamp(s), driver information center messages, lights turning off, no start, loss of propulsion, and/or loss of power steering assist.
Correction	Torque the battery negative cable nut to specified torque.

GMC Acadia shown. Cadillac XT5 similar.

- 2. Locate G105 (1).
- 3. Verify the nut for G105 is torqued to 22 Nm (16 lb ft).
  - If the nut for G105 is torqued to 22 Nm (16 lb ft), no further action is required.
  - If the torque on the nut for G105 is LESS than 22 Nm (16 lb ft), torque the nut to 22 Nm (16 lb ft).
- 4. Remove the fender covers and close the hood.
