Bulletin No.: 06-03-09-004I

Service Bulletin

Subject: Squeak Noise from Rear of Vehicle (Lubricate Rear Leaf Springs)

Models: 1999-2007 Chevrolet Silverado (Classic)
2007-2012 Chevrolet Colorado
2007-2017 Chevrolet Silverado
2015-2017 Chevrolet Colorado
1999-2007 GMC Sierra (Classic)
2007-2012 GMC Canyon
2007-2017 GMC Sierra
2015-2017 GMC Canyon
2007-2010 HUMMER H3, H3T

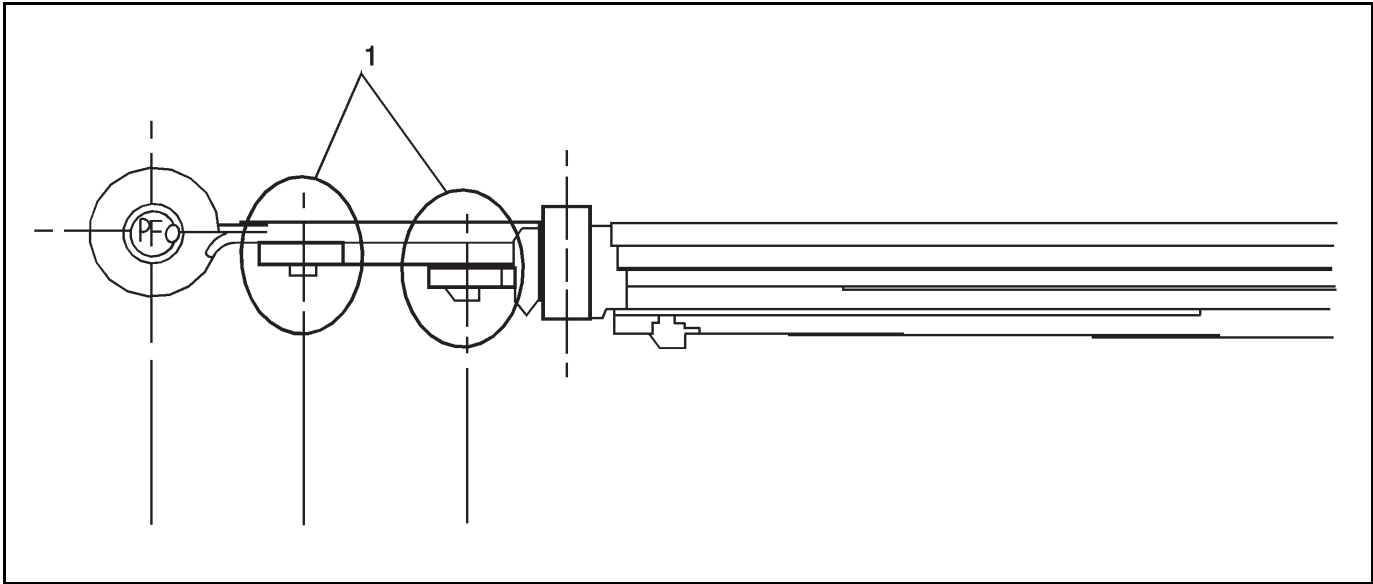
1826776

Some customers may comment about a squeak noise coming from the rear of the vehicle. During normal operation, certain vehicles may exhibit a squeaking noise that may be traced to the rear leaf springs. While this noise is an operating characteristic of leaf springs, the frequency and severity of this noise will be affected by the roads that the vehicle is driven on.

This condition may be due to debris getting between the leaf springs.

5. Apply a liberal amount of grease, P/N 19356408 (in Canada, use P/N 19356409), both underneath and on top of the front and rear tip inserts for the #2 and #3 leaves, as indicated above. A screwdriver can be used to gently pry up the leaf; however, a rag around the screwdriver must be used to prevent damage to the leaf. Use a flat-bladed tool, such as a gasket scraper or a brush to properly distribute the grease at least 6 inches from each end of the leaf.
6. Lower the vehicle to the ground and test drive to verify the repair.
