Service Bulletin

Bulletin No.: 16-NA-046

Subject: A/C Inoperative, Blows Warm or Poor Performance Due to Low Refrigerant Charge, Refrigerant Leak

Brand:	Model:	Model Year:		Breakpoint:		Engine:	Transmission:
		from	to	from	to		
Buick	Enclave	2013	2016	Vehicles Built Prior to October 6, 2015		All	All
Chevrolet	Traverse	2013	2016				
GMC	Acadia	2013	2016

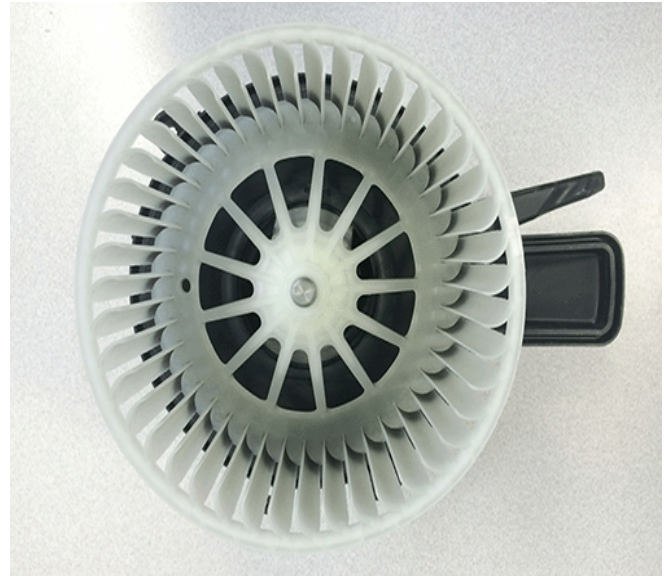
4840376

- An original blower motor will contain a cage with openings, as shown in the graphic above. **These original motors should be replaced, and not reinstalled.** Refer to *Auxiliary Blower Motor Replacement* in SI.

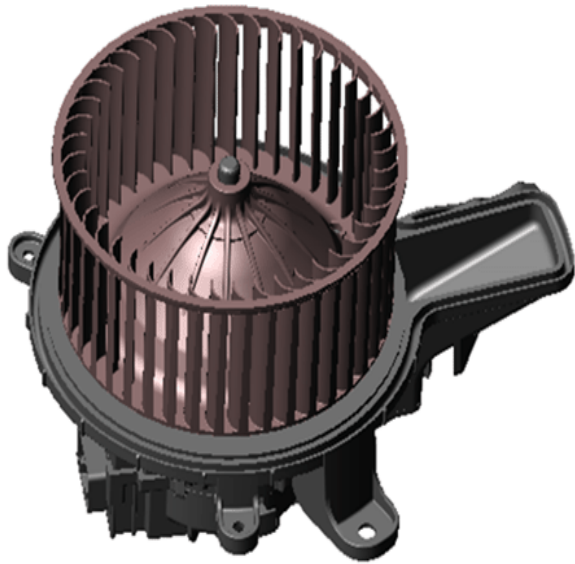
4840377

- A replacement blower motor will contain a closed cage, as shown in the graphic above. A replacement blower motor can be reinstalled. Refer to *Auxiliary Blower Motor Replacement* in SI.
