Service Bulletin

File in Section: -
 Bulletin No.: 17-NA-118
 Date: July, 2017

Subject: Information on Body Seam Locations as Possible Intrusion Areas for Water Leaks, Musty Odor, Wet Carpet and/or Water Leaking on Driver Side Floor

Brand:	Model:	Model Year:		VIN:		Engine:	Transmission:
		from	to	from	to		
Chevrolet	Trax	2016	2017			All	All

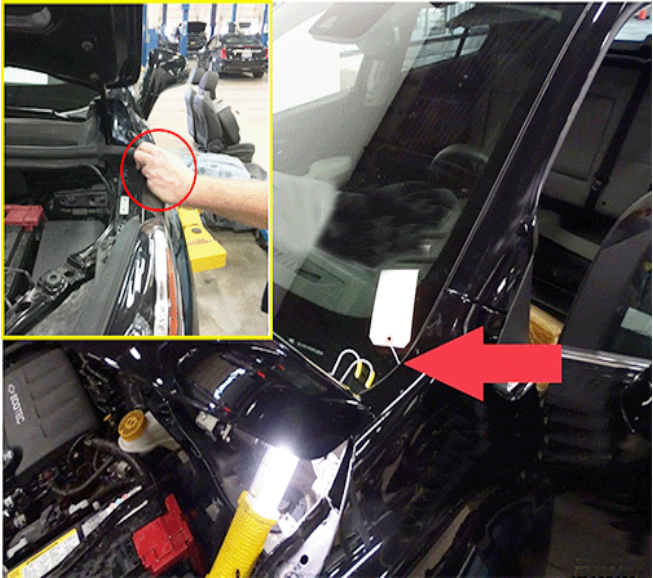
<p style="text-align: right;">4771191</p> <p>The cause of the condition may be voids in one or several body seam areas. The tag/wire noted by the arrow in the graphic above is pointing to one of the more common locations at the driver A-pillar.</p>
Correction	Using Kent Automotive High-Tech™ Clear Seam Sealer, or equivalent, reseal the body seam areas referenced in the Service Procedure below.

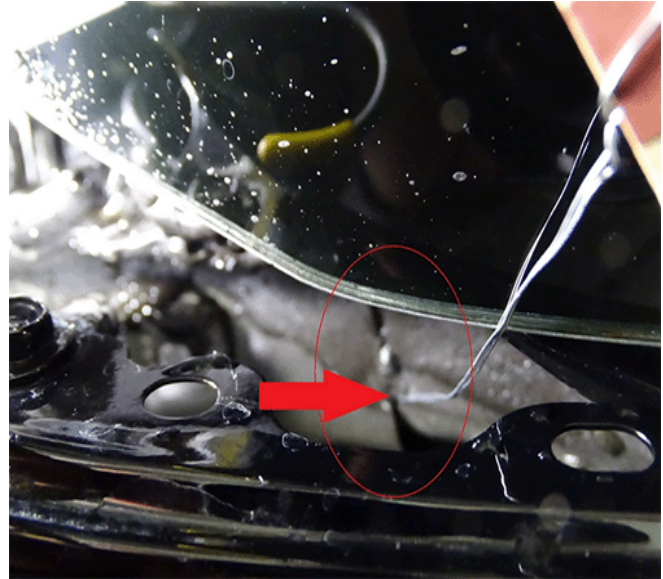
4771197

- Inspect the driver side upper hinge pillar seam (below the windshield edge, behind the hood hinge), again shown by the tag/wire in the graphic above.

6. Seal any voids/gaps in these areas with Kent Automotive High-Tech™ Clear Seam Sealer P/N P10200, or equivalent (1).
7. Repeat water test to ensure leaks have been eliminated.
8. Reinstall the wiper transmission. Refer to *Windshield Wiper Transmission Replacement* in SI.
9. Reinstall any carpet/trim that was removed.

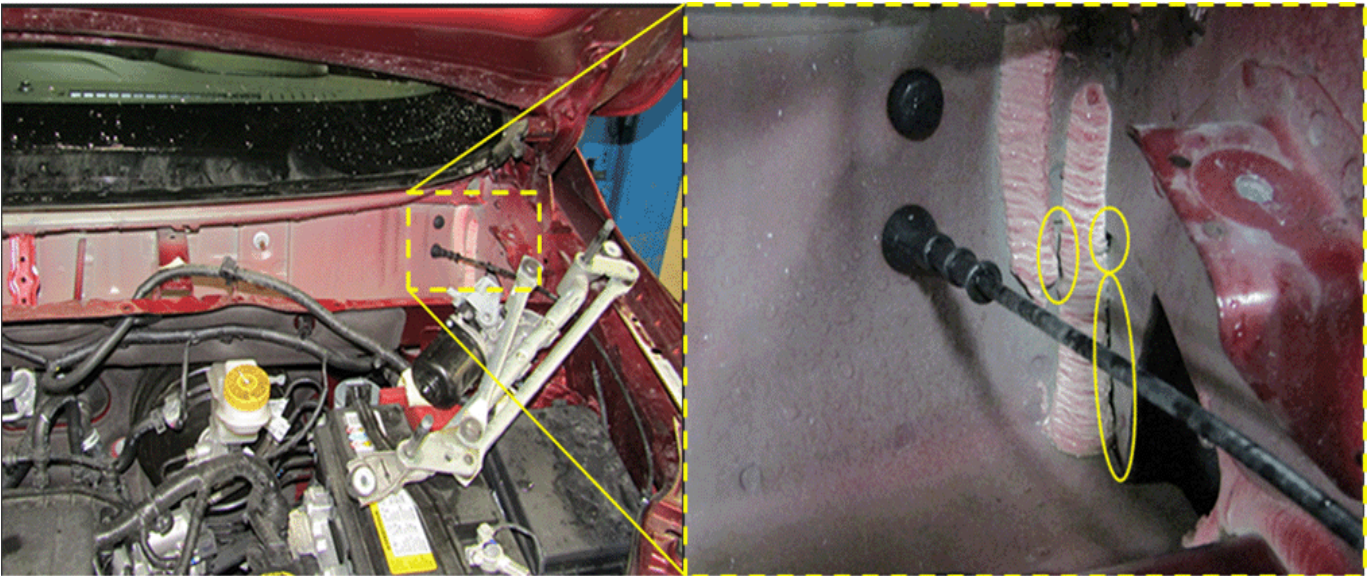
4771199

- Inspect the vertical body seam in the cowl area, shown circled in the graphic above.

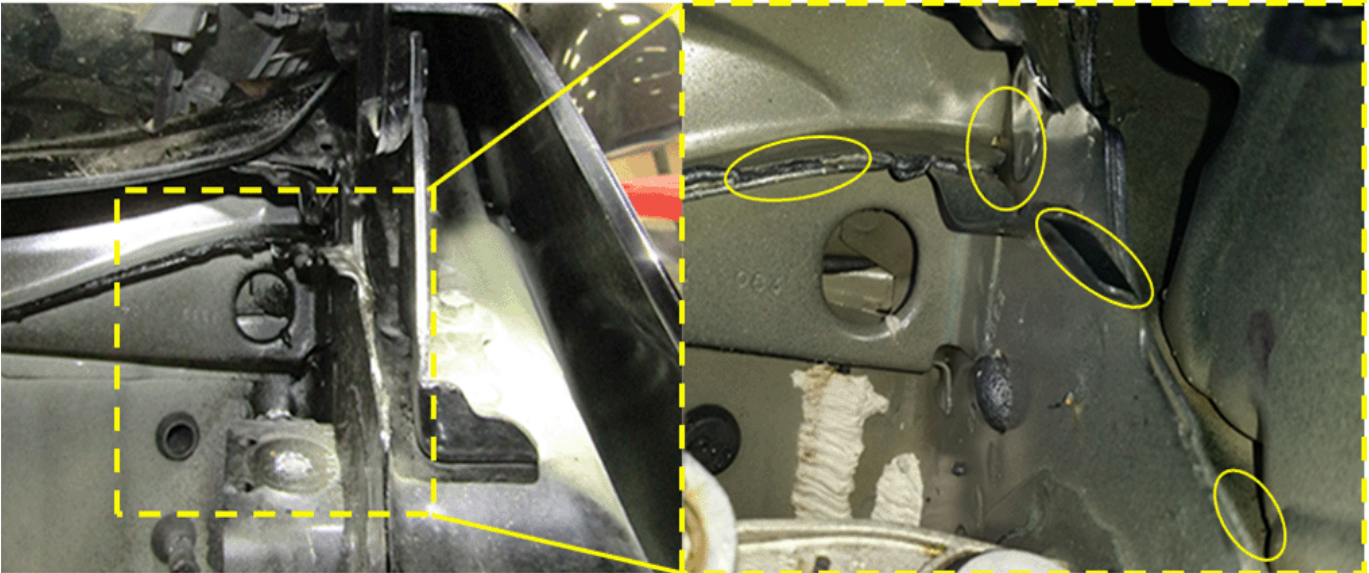
4839809

- Also inspect the horizontal seams shown circled in the graphic above.
