Service Bulletin

Bulletin No.: 17-NA-206

Subject: Information on Liftgate Power Assist Actuator Oil Leakage

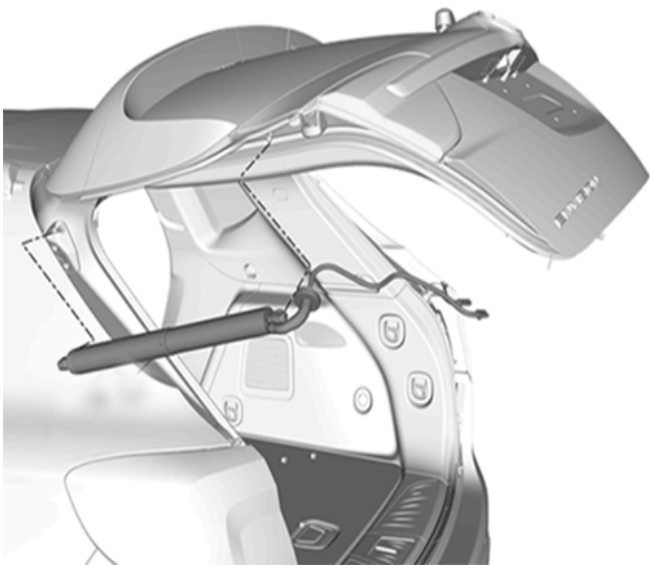
<p style="text-align: right;">4825202</p> <p>Some customers may comment that the liftgate power assist actuator appears to be leaking.</p>

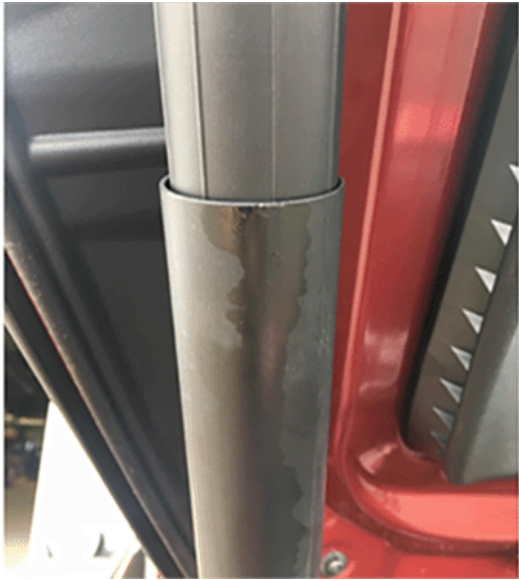
<p>4833281</p>

<p>4833286</p> <p>Important: The liftgate power assist actuator IS NOT filled with oil. Note: Examples of the leak appearance are shown in the graphics above.</p> <p>The cause of the condition may be that a grease, applied to the internal actuator spring for noise abatement, may break down during normal use and a small amount of an oil component of the grease may leak out.</p>
<p>Correction</p>	<p>Important: The actuator is functioning as designed and SHOULD NOT BE REPLACED.</p> <p>Wipe or clean the small amount of grease/oil from the surface of the actuator. Please communicate to the customer that the actuator is functioning as designed, and the cleaning of the actuator will only improve the appearance.</p> <p>Please share this information with the customer, including a copy of this message.</p>

Labor Operation	Description	Labor Time
2080858*	Clean Oil Residue from Liftgate Actuator	0.2 hr
*This is a unique Labor Operation for Bulletin use only.
