# Service Bulletin

Bulletin No.: 17-NA-209

**Subject: Water Found in Rear Compartment and/or Rear Passenger Floor Area**

Brand:	Model:	Model Year:		VIN:		Engine:	Transmission:
		from	to	from	to		
Chevrolet	Malibu (VIN Z)	2016	2016			All	All
Chevrolet	Malibu	2017	2017	SOP	Prior to HF216475

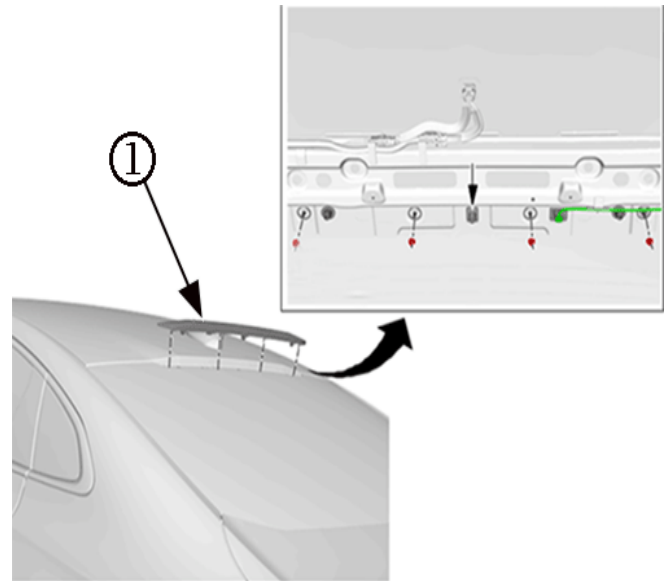
4822952

<b>Involved Region or Country</b>	North America, Israel
<b>Condition</b>	Some customers may comment on finding water in the rear compartment and/or rear passenger floor area.
<b>Cause</b>	The cause of the condition may be that over time, the center high mount stop lamp (CHMSL) fasteners may lose torque and allow water to leak into the rear compartment or floor area. The fasteners may lose torque due to thermal expansion and contraction of the CHMSL material.
<b>Correction</b>	Replace the CHMSL fasteners, and repair/replace any water damaged trim following the Service Procedure below.

1. Remove the CHMSL (1). Refer to *High Mount Stop Lamp Replacement* in SI.
2. Reinstall the CHMSL and replace the original fasteners with the service part nuts listed in the part table. Refer to *High Mount Stop Lamp Replacement* in SI.
3. Repair or replace any water damaged trim, as necessary. Refer to *Floor Carpet Drying* in SI.
