Service Bulletin

Bulletin No.: 17-NA-219

Subject: Diagnostic Tip for Malfunction Indicator Lamp (MIL) Illuminated, Auto Stop Inoperative - DTC U029D, U029E, P249D, P249E Set

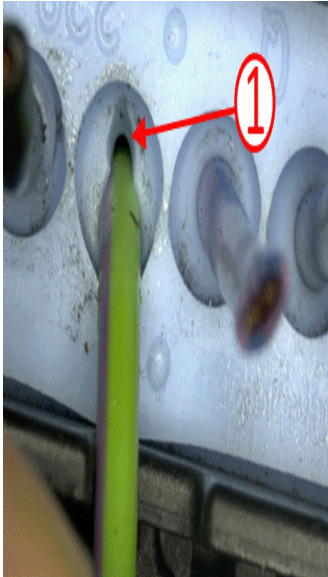
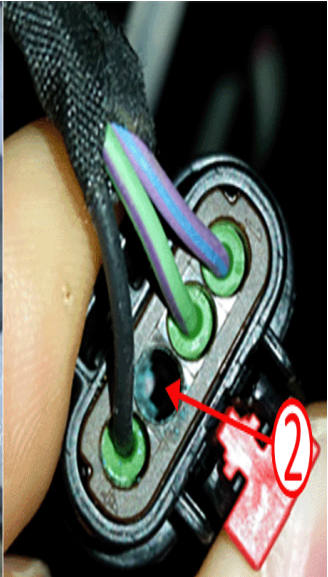
4787001

<p>Note: The graphic above depicts an example of a torn and missing seal.</p> <ul style="list-style-type: none"> • Moisture intrusion past a damaged (1) seal located in the connector for the NOx sensor wiring harness. • Missing (2) seal located in the connector for the NOx sensor wiring harness.
Correction	<p>If you encounter a vehicle with the above concern, perform normal diagnostics for the codes set.</p> <p>⇒ If diagnostics lead to NOx sensor replacement, inspect the mating chassis electrical connector for corrosion. Clean and repair as necessary.</p>
