## **Service Bulletin**

Bulletin No.: 17-NA-222

**Subject: Turbocharger Whine Noise**

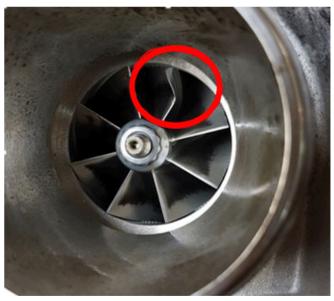
4818843

Involved Region or Country	North America and N.A. Export Regions
Additional Options (RPOs)	Equipped with 2.8L Diesel Engine (RPO LWN)
Condition	Some customers may comment on a whine noise during acceleration, in gear, or Neutral.
Cause	This condition may be caused by a bent turbocharger compressor blade.
Correction	Replace the turbocharger.

If you encounter a vehicle with the above concern, inspect the turbocharger compressor blades.

If one of the blades is bent as illustrated above, replace the turbocharger. Refer to *Turbocharger Replacement* in SI
