Service Bulletin

Bulletin No.: 17-NA-229

Subject: Moisture/Dampness Found in Front Floor Foot Well Area and/or Repeat Radio Inoperative

Brand:	Model:	Model Year:		Date Breakpoint:		Engine:	Transmission:
		from	to	from	to		
Chevrolet	Malibu (VIN Z)	2016	2016			All	All
Chevrolet	Malibu	2017	2017	SOP	Prior to January 23, 2017

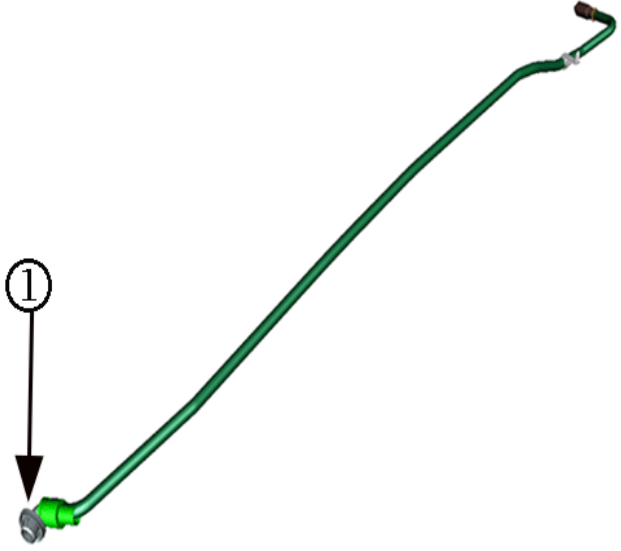
Involved Region or Country	North America, Israel
Condition	Some customers may comment on finding moisture or dampness in the front floor foot well area on either side of the vehicle, or they may have repeat radio module failures.
Cause

<p style="text-align: right;">4830083</p> <p>The cause of the condition may be the end grommet (1) of the front sunroof drain hose may not be completely seated into the cowl sheet metal opening, allowing water to drip into the passenger compartment.</p>
Correction	<p>Note: All vehicle have plugs at these locations, however vehicles with sunroofs have the drain hose grommet that allows water to exit. Either the grommet or body plug could leak if not fully seated.</p> <p>R & R the air inlet grille panel and fully seat both front sunroof drain hose grommets, or body plugs, following the Service Procedure below.</p>
