# Service Bulletin

Bulletin No.: 17-NA-232

**Subject: Power Liftgate Stops When Opening and/or Will Not Close from Open Position, DTC B153E or B396A Set**

Brand:	Model:	Model Year:		VIN:		Engine:	Transmission:
		from	to	from	to		
Chevrolet	Equinox (VIN X)	2018	2018			All	All
GMC	Terrain

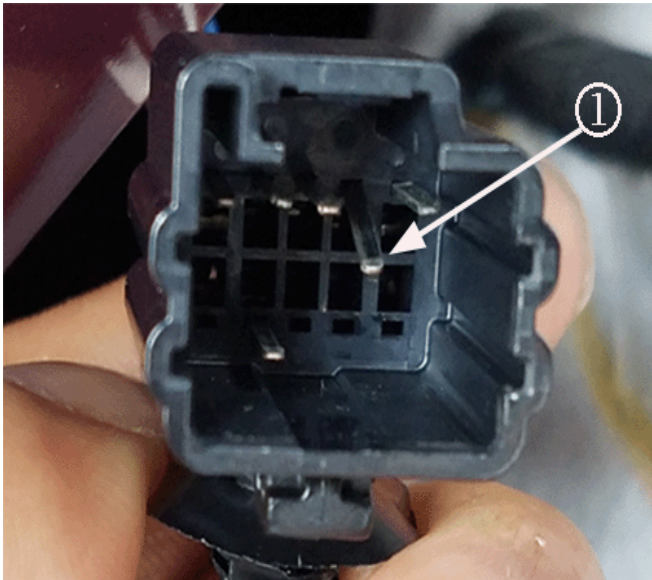
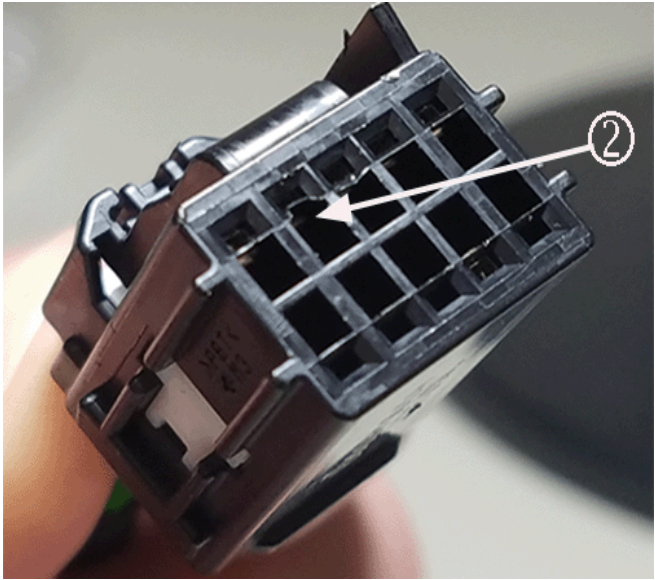
<p style="text-align: right;">4834001</p> <p><b>Note:</b> Examples of the bent pin condition are shown in the male terminal side (1) and mating side female terminal (2) connector graphics above.</p> <p>The cause of the condition may be that the male terminals in the body harness 10-way in-line connector to the liftgate power assist actuator may not be dimensionally stable and/or misaligned, causing intermittent electrical contact.</p>
<p><b>Correction</b></p>	<p><b>Important:</b> DO NOT replace the liftgate power assist actuator or the power liftgate ECU before first inspecting the connector as possible cause of the condition.</p> <p>Inspect the body harness to liftgate power assist actuator connector and repair as necessary following the Service Procedure below.</p>

4. Inspect the body harness male in-line connector for any bent or misaligned terminals. Straighten any misaligned male terminals.
5. Reconnect the connectors and verify proper power operation of the liftgate opening/closing.
6. Reposition the body harness and reinstall the headliner. Refer to *Headlining Trim Panel Replacement* in SI.
