# Service Bulletin

Bulletin No.: 17-NA-234

**Subject:** Elevation Edition Equipped with Wrong Rear Bumper

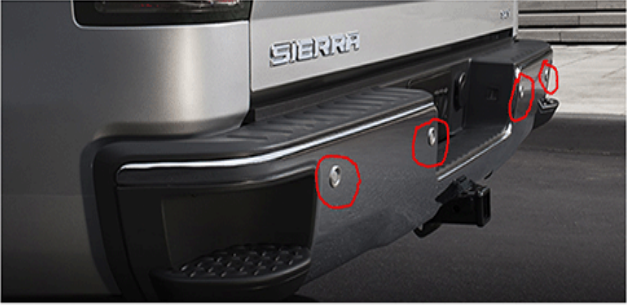
<b>Involved Region or Country</b>	North America
<b>Additional Options (RPOs)</b>	Equipped with SALES PACKAGE - ELEVATION EDITION (SXL), PRIMARY COLOR - EXTERIOR, GASOLINE MET-2 (GPA) and <b>minus</b> REAR PARK ASSIST (- UD7).
<b>Condition</b>	Some customers may notice sensors are present on the rear bumper and assume the rear park assist feature is available, but inoperative.
<b>Cause</b>	<div style="text-align: center;">

</div> <p style="text-align: right;">4830979</p> <p>The cause of the condition may be that vehicles were incorrectly over-built from the plant with rear bumpers containing unrequired, non-functional sensors.</p>
<b>Correction</b>	Replace the rear bumper assembly with the Non - UD7 rear bumper listed in the Part Table below. Refer to <i>Rear Bumper Impact Bar Replacement</i> in SI.
