Service Bulletin

Bulletin No.: 17-NA-236

Subject: Rattle Noise from Front Door during Deep Bass Tones that May be Mistaken for Blown Speaker

Brand:	Model:	Model Year:		VIN:		Engine:	Transmission:
		from	to	from	to		
Cadillac	XT5	2017	2018			All	All

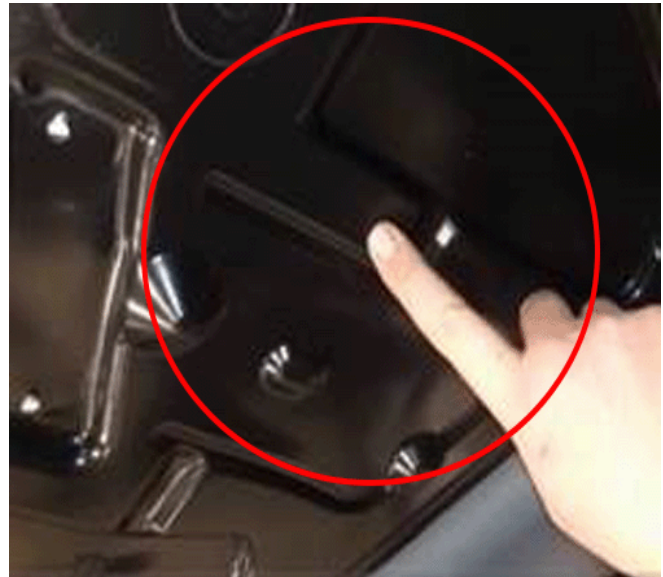
4839330

Once the noise is verified, push on the interior door trim panel in different locations while the noise is happening. If the noise changes, the noise is coming from the interior door trim panel and this bulletin does not apply. If the noise does not change, remove the interior trim panel and apply pressure to the suspect

location of the plastic water deflector shown above. Refer to the *Front Side Door Trim Replacement* procedure in SI.
