Service Bulletin

Bulletin No.: 17-NA-240

Subject: Front Bumper Fascia Out of Alignment

Brand:	Model:	Model Year:		VIN:		Engine:	Transmission:
		from	to	from	to		
Buick	Encore	2017	2017	SOP	April 11, 2017	All	All

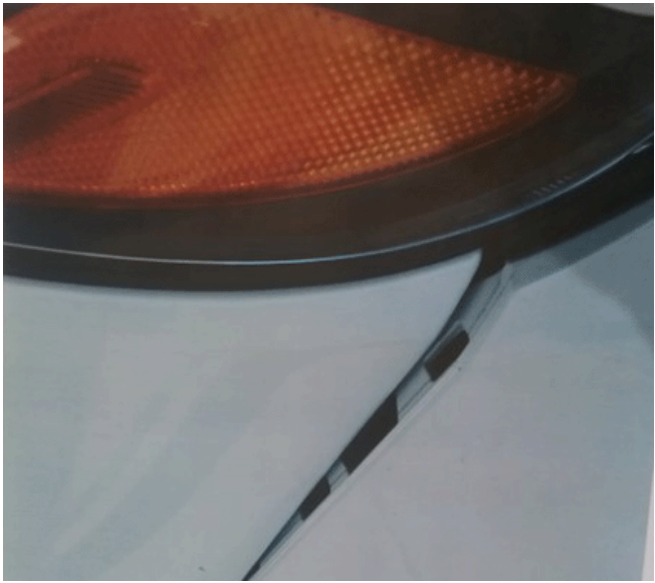
<p style="text-align: right; font-size: small;">4840393</p>
Cause	Some customers may comment that the front fascia is loose or out of alignment. This may be due to the body mounting surface being out of specification.
Correction	Adjust the fender by following the Service Procedure listed below.
