Service Bulletin

Bulletin No.: 17-NA-241

Subject: Charge Port Bezel Preventing Charging when Plugging in Charging Handle

Brand:	Model:	Model Year:		VIN:		Engine:	Transmission:
		from	to	from	to		
Chevrolet	Volt	2017	2017

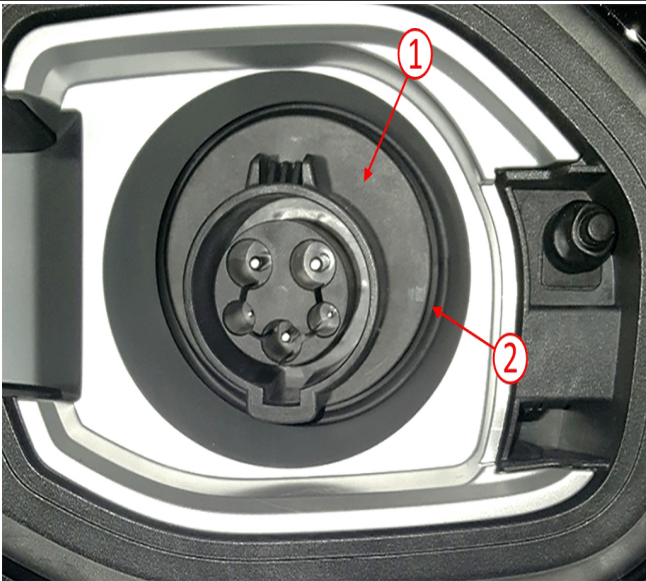
Involved Region or Country	North America, Europe, South Korea
Condition	Some customers may comment that the charging plug will not plug into the charging port.
Cause	<div>

</div> <p>4839448</p> <p>This condition may be caused by the charge port seal (2) not installed correctly around the receptacle (1) when being installed at the assembly plant.</p>
