# Service Bulletin

**Subject:** Wax Coating on Frame Peeling, Metal Shows Corrosion/Rusting (U.S. and Canada Only)

**Models:** 2011-2017 Cadillac Escalade Models  
2011-2013 Chevrolet Avalanche  
2011-2017 Chevrolet Express, Silverado, Suburban, Tahoe  
2011-2017 GMC Savana, Sierra Models, Yukon Models

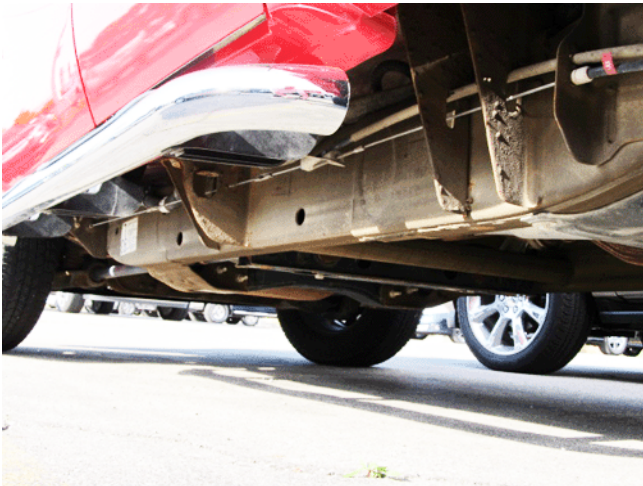
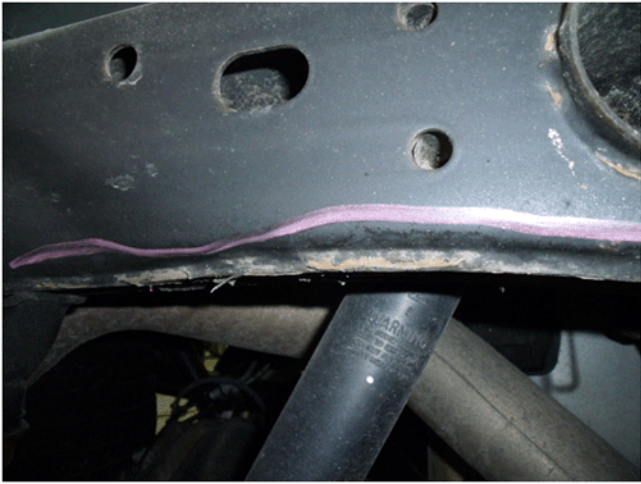
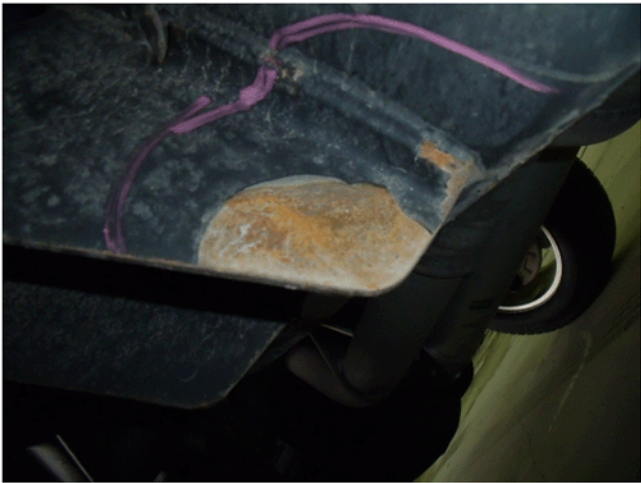
### Truck Example Photos

Some customers may comment that areas of the frame wax coating are peeling off and rust/corrosion is visible on the metal in these areas. Several examples of this condition are shown in each group of graphics below.

A combination of specialized metal coating products manufactured by Lloyds and Daubert have been found to be the most suitable products to provide corrosion control and protection to address this type of repair. Our recommendation is to prep the metal surface using \*Lloyd's Pure Prep™ Metal Surface Preparation P/N 25418, then topcoat with both \*Lloyds Kryptonite Metal Treatment P/N 36502 Life Long Rust Protection and \*Daubert Non-Rust® P/N X-121B One Coat Rust Preventative Coating. It is strongly recommended they be applied according to the manufacturer's procedures.
