Service Bulletin

PRELIMINARY INFORMATION

Subject: Warm Air Exhausting from Driver and/or Passenger Front Seat Back into 2nd Row Seating Area Causing Occupant Discomfort

Models: 2015-2017 Cadillac Escalade Models
2014 Chevrolet Silverado 1500
2015-2016 Chevrolet Silverado, Suburban, Tahoe
2014 GMC Sierra 1500
2015-2016 GMC Sierra, Yukon Models
Equipped with Heated and Cooled Seats - Driver and Passenger Front (RPO KB6)

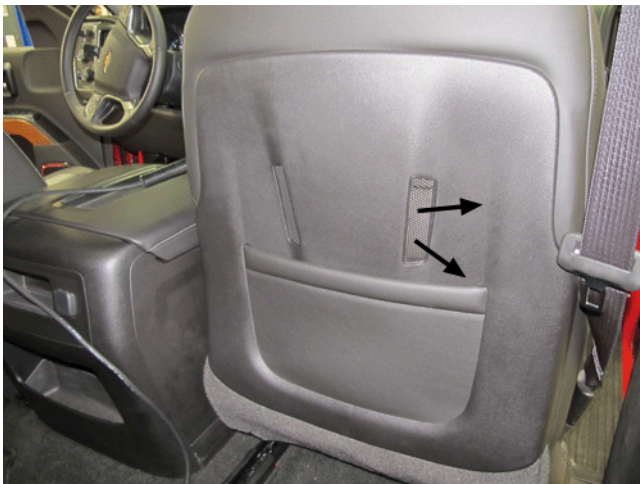
Some customers may comment on warm air exhausting from the driver/passenger front seat back into the 2nd row seating area, causing occupant discomfort.

The cause of this condition may be that during cooled seat operation, a direct flow of warm air exhausts from the upper seat back ventilation heating/cooling blower thermal exchange blower unit.
