Service Bulletin

PRELIMINARY INFORMATION

Subject: Turbocharger Wastegate Brief Rattle or Tick When Revving Engine in Park/Neutral

Models: 2014-2016 Cadillac CTS Sedan (VIN A), XTS
Equipped with 3.6L, SIDI, DOHC, VVT, TWIN TURBO Engine – RPO LF3
2016 Cadillac ATS-V
Equipped with 3.6L, SIDI, DOHC, VVT, TWIN TURBO Engine – RPO LF4

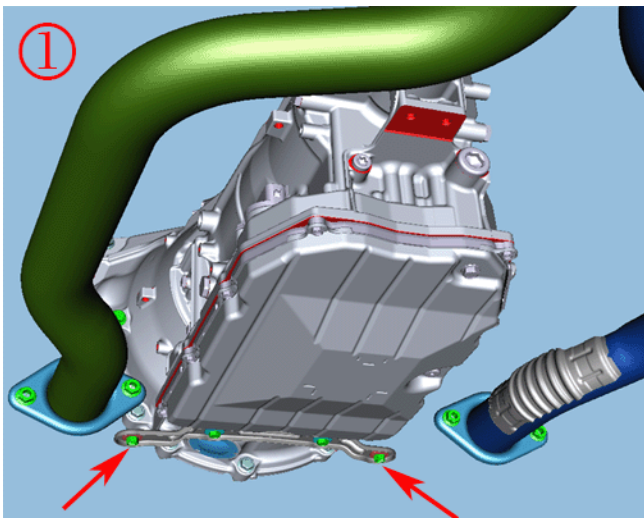
This condition may be caused by loose converter brackets nuts or a normal characteristic of the turbocharger (TC) wastegate.

Inspect the M8 nuts that secure the catalytic converters to the exhaust bracket. RPO LF3 (1) and RPO LF4 (2) as shown above. If the nuts are loose, it is necessary to replace them with new torque prevailing nuts.

If the technician finds that the nuts are torque correctly, **DO NOT** replace the turbocharger assembly in an effort to eliminate this brief rattle or tick.
