## NYCT COMPRESSOR DOOR HINGES REPLACEMENT

Prevost vehicles

On the vehicles affected by this bulletin, the compressor door hinges must be replaced by new improved hinges providing better door retention.

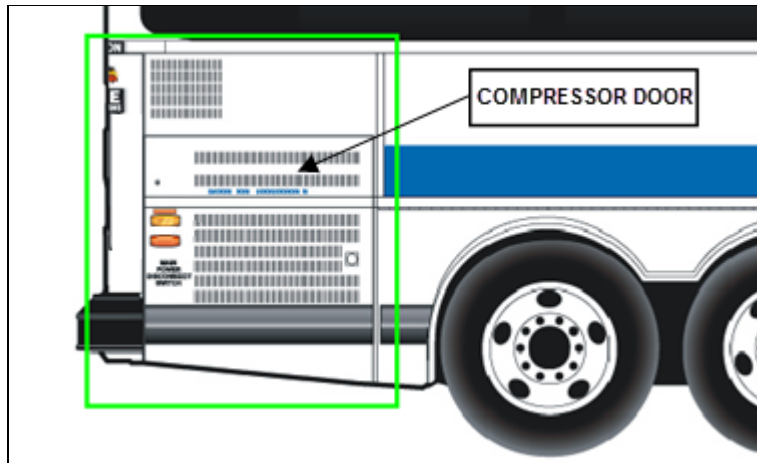
FIG.1 VEHICLE COMPRESSOR DOOR

1. Fully open the vehicle compressor door (rear, curb side of vehicle Fig.1).

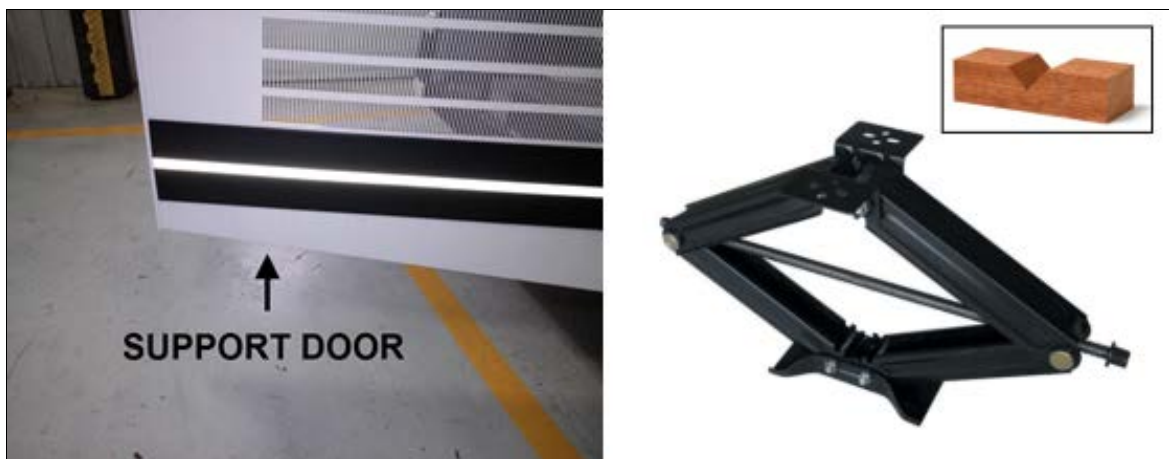
FIG.2 SUPPORTING THE DOOR

2. Support the door at its lower edge without applying upward pressure. A scissor jack (or equivalent lifting equipment) and a V shaped wood block are recommended (Fig.2).

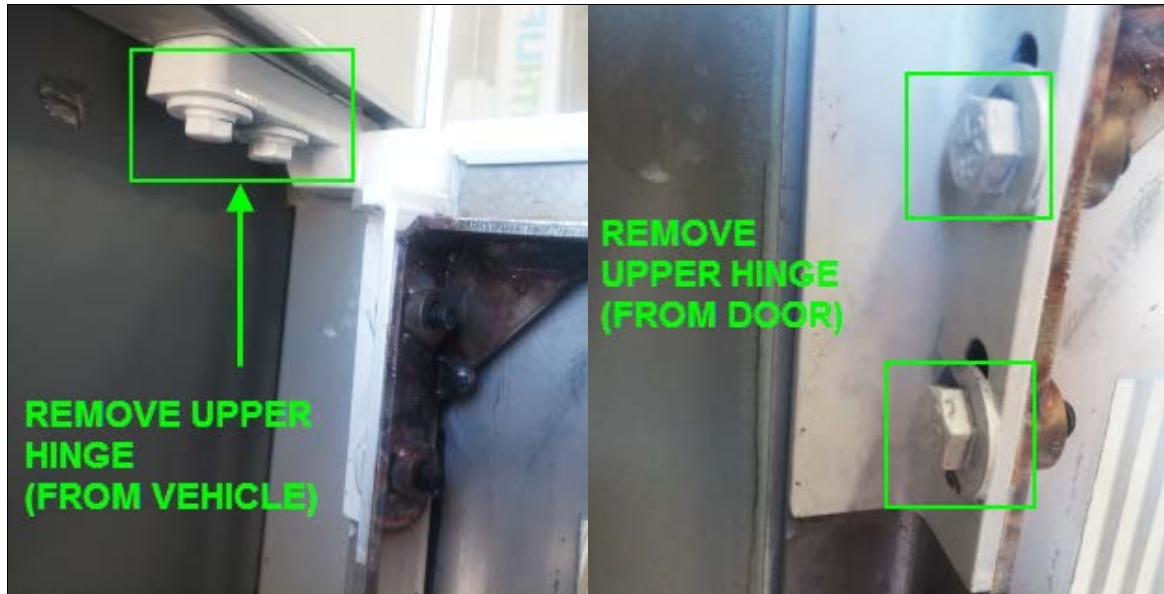
FIG.3 UPPER HINGE REMOVAL

3. Unscrew and remove both parts of the upper hinge (4X M6 bolts at frame and door). Discard all parts and hardware (Fig.3).

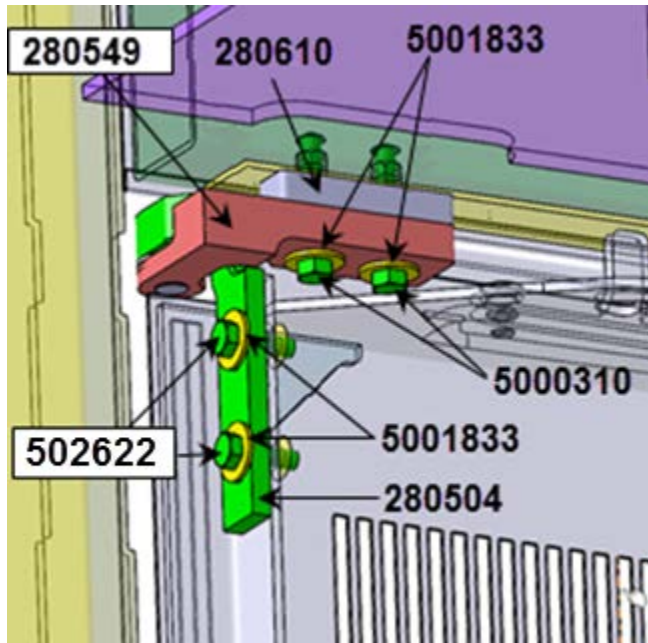
FIG.4 NEW UPPER HINGE

4. Install the new upper hinge (parts **280504**, **280549** & **280610** in kit Fig.4) making sure that:
  - New M6 bolts and washers (**5000310** & **5001833**) are used at the upper (vehicle structure) mounting points (Fig.4).
  - New M6 bolts (**502622** & **5001833**) are used at the door mounting points (Fig.4).
  - A new plastic bushing **284607** is installed at the pivot point (Fig.5).
  - The door is fully supported by the *lower hinge* and not slightly lifted-up by the lift table so there is no gap between parts at the lower pivot point (Fig.6).
  - There is no gap between the upper and lower part at the pivot point of the upper hinge (Fig.7).
  - The four M6 bolts are torqued to **68 lb-in** (apply blue Loctite 242 or equivalent medium strength thread locker on all fastener threads (Fig.8)).

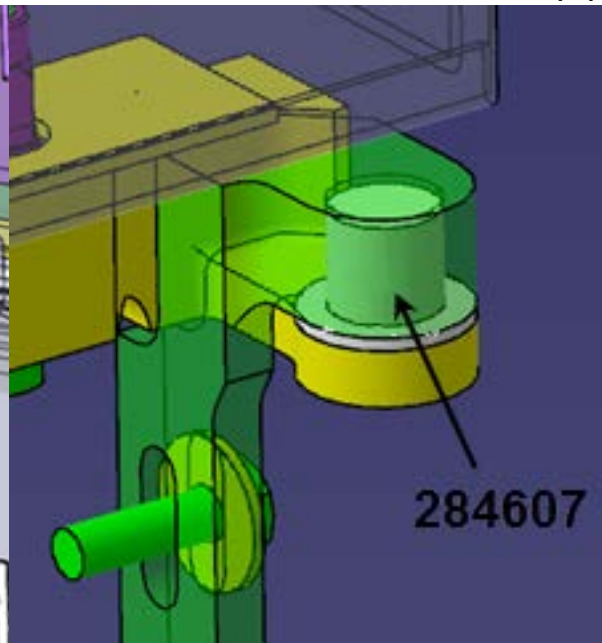
FIG.5 BUSHING

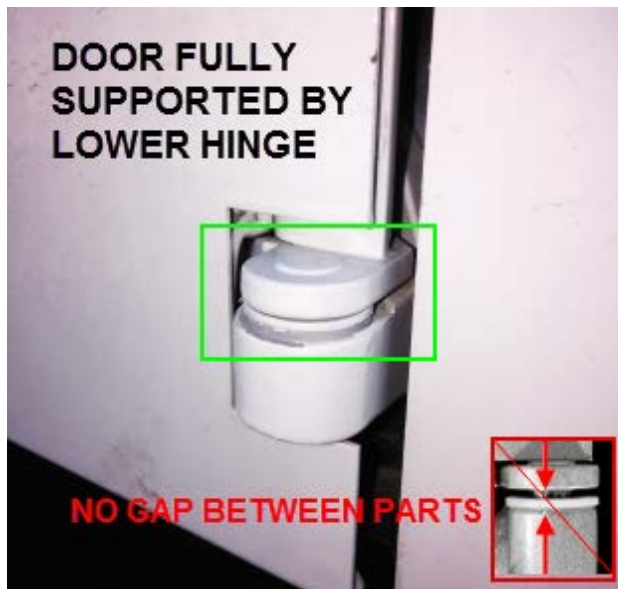
FIG.6 LOWER HINGE SUPPORT

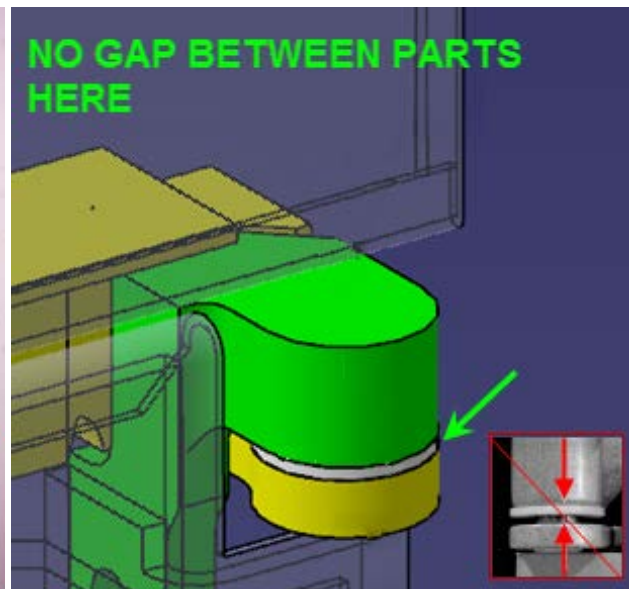
FIG.7 NO GAP - UPPER HINGE

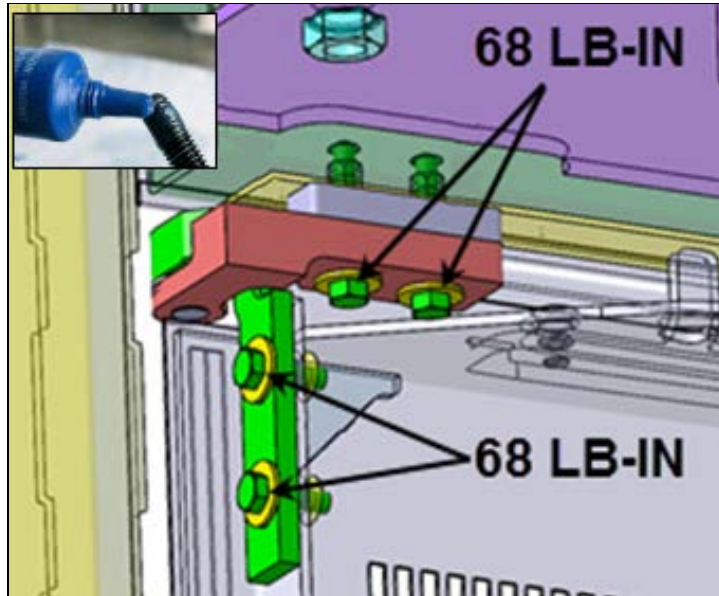
FIG.8 TIGHTENING TORQUE- UPPER HINGE

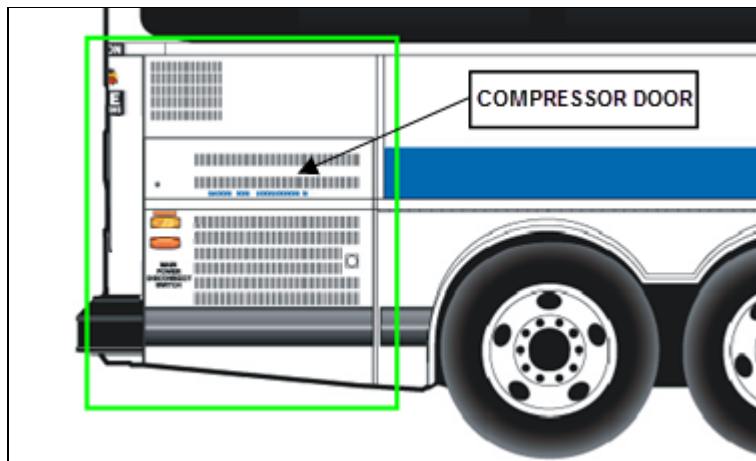
FIG.9 VEHICLE COMPRESSOR DOOR

1. Fully open the vehicle compressor door (rear, curb side of vehicle Fig.9).

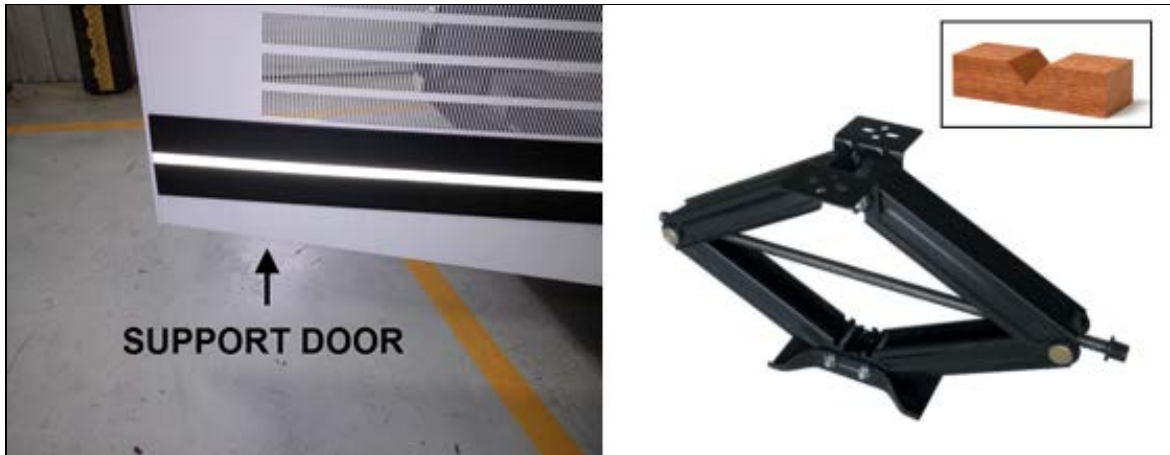
FIG.10 SUPPORTING THE DOOR

2. Support the door at its lower edge without applying upward pressure. A scissor jack (or equivalent lifting equipment) and a V shaped wood block are recommended (Fig.10).

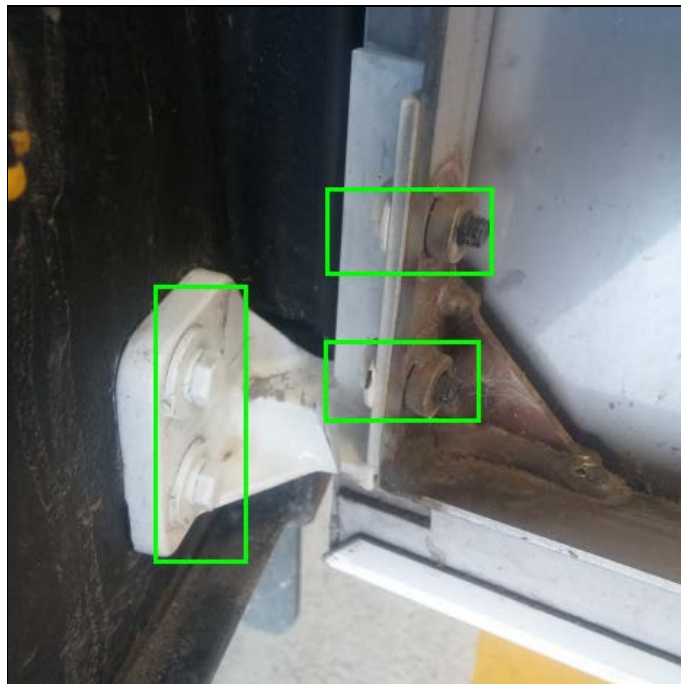
FIG.11 LOWER HINGE BOLTS

3. Unscrew and remove *both parts* of the lower hinge (4X M6 bolts Fig.11)

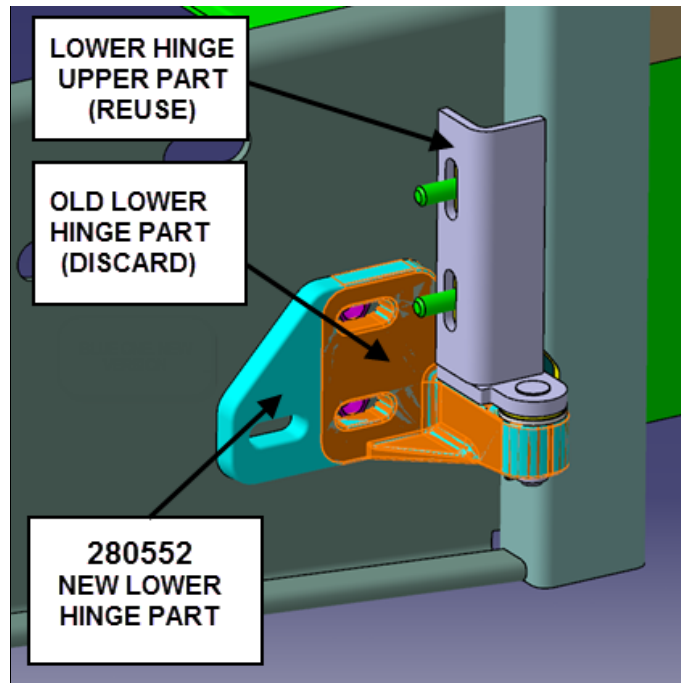
FIG.12 NEW VS OLD LOWER HINGE PARTS

4. Discard the *lower* (vehicle structure) part of the lower hinge and replace it with the new **280552** part supplied with the kit (reuse the door part of the hinge but discard hardware Fig.12).

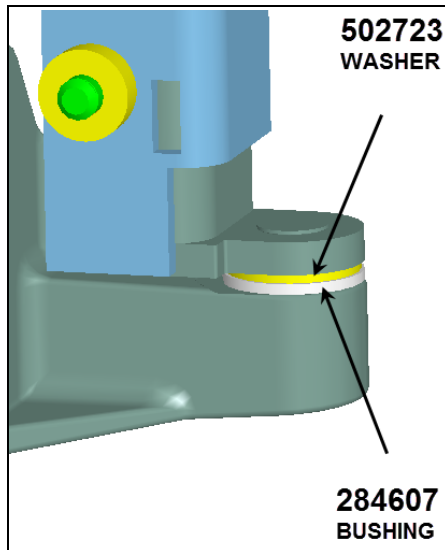
FIG.13 WASHER & BUSHING POSITION

5. Reinstall the lower hinge (with new lower part) making sure that:
- New plastic bushing **284607** and washer **502723** are installed at the pivot point (Fig.13).
  - Door is fully supported by the *top hinge*, not the lift table (no gap at the pivot point) (Fig.14).
  - New M6 bolts and washers (**5001697 & 5001833**) are used at the door mounting points (Fig.15).
  - New M6 bolts, locks & washers (**502686, 502570 & 430406**) are used at the vehicle structure point (Fig.15).
  - All four lower hinge bolts (vehicle *and* door frame) are torqued to **68 lb-in** (apply blue Loctite 242 or equivalent medium strength thread locker on all fastener threads (Fig.16)).

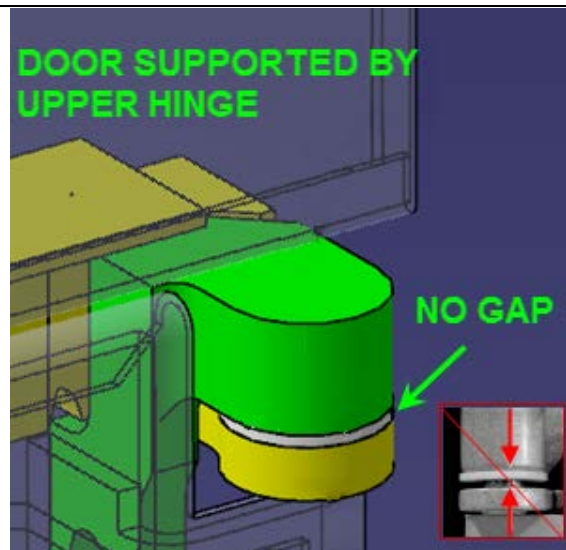
FIG.14 UPPER SUPPORT- NO GAP

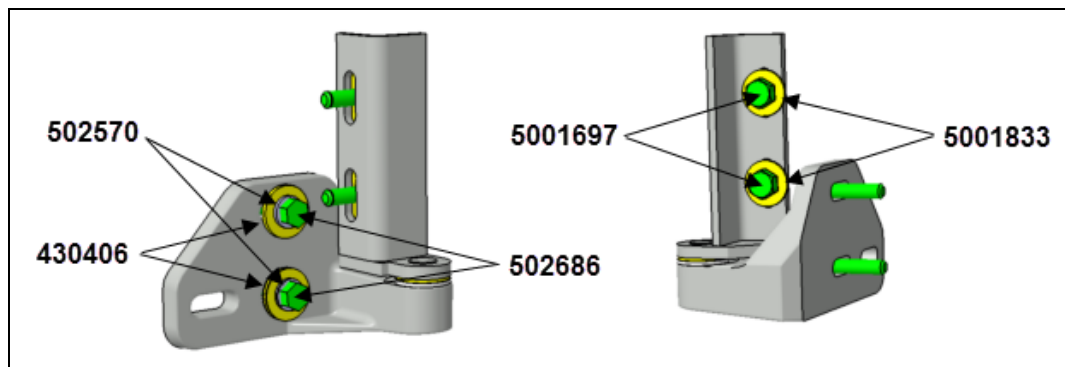
FIG.15 NEW HARDWARE TO BE INSTALLED - LOWER HINGE

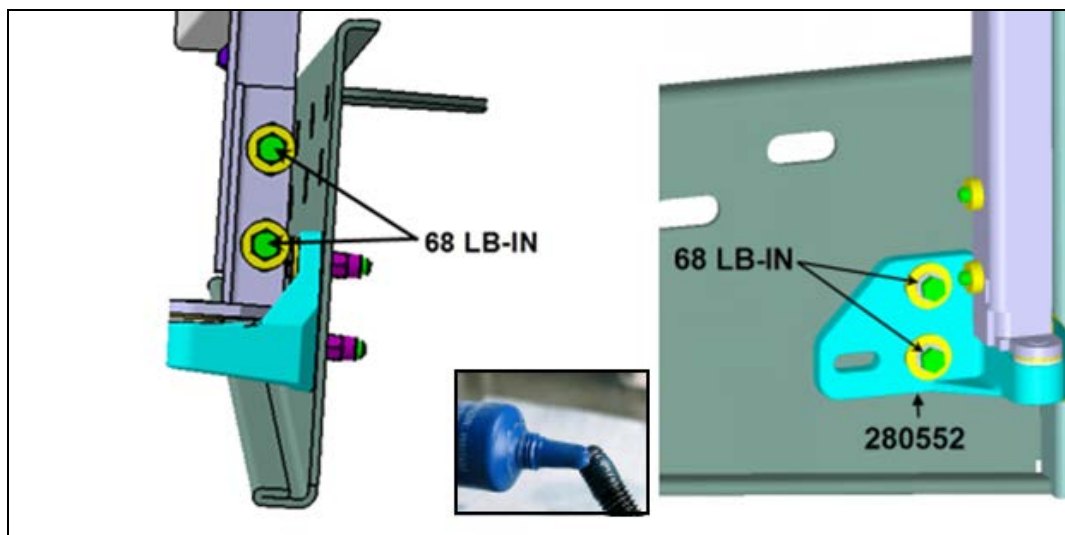
FIG.16 LOWER HINGE TIGHTENING TORQUE

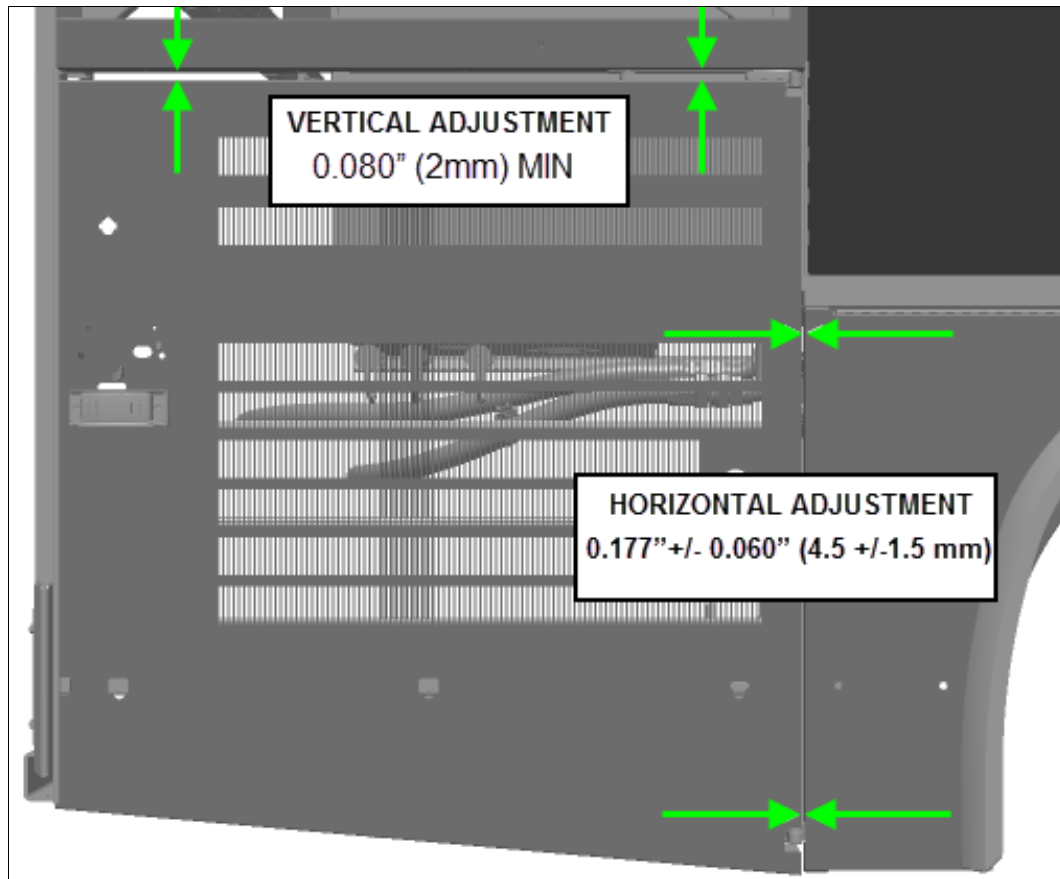
FIG.17 COMPRESSOR DOOR HORIZONTAL & VERTICAL GAPS

6. Remove door support installed at step 2 and open and close the door several times to make sure it is working properly, check door top and side adjustments. There should be an even (parallel) gap of at least 0.080" (2mm) at the top of the door and a 0.177" +/- 0.060" (4.5 +/-1.5 mm) gap between the door and the vehicle rear fender (Fig.17).

*If gap is out of spec the compressor door may be adjusted for proper fit by untightening hinge bolts:*

- *Loosen the bolts holding the hinge to the vehicle structure to shift the door horizontally LEFT or RIGHT.*
- *Loosen the bolts holding the hinge to the door frame to shift the door vertically UP or DOWN.*

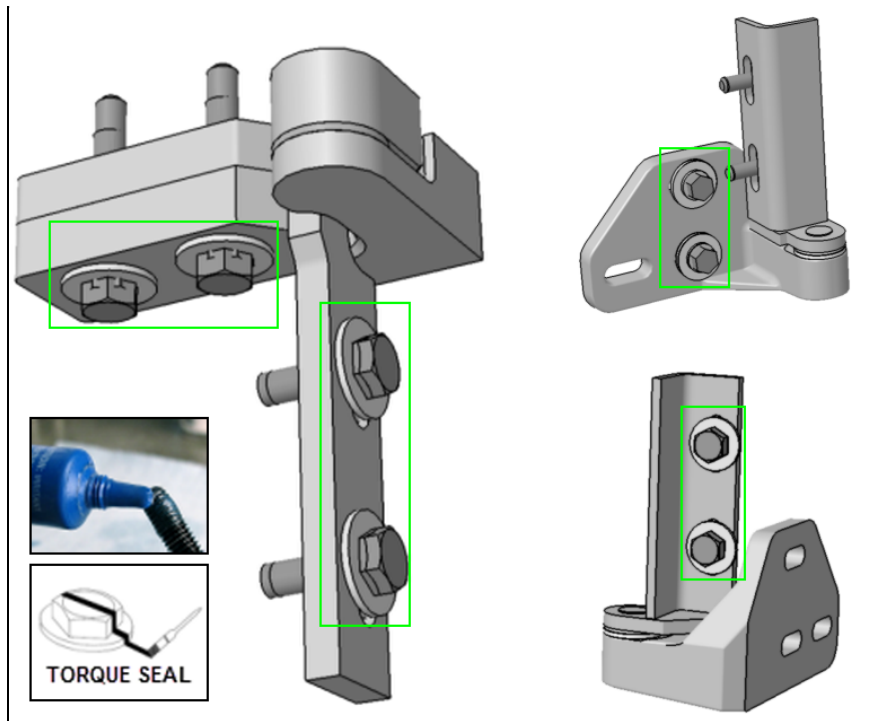
FIG.18 RE-APPLY THREAD LOCKER AS NECESSARY AND APPLY TORQUE SEAL

7. With the door gaps correctly adjusted, re-apply blue, *medium strength thread locker* on the loosened bolts (one at the time – do not disturb adjustment), re-torque fasteners to the specified torque (**68 lb-in**) and apply a stripe of tamper proof indicator paint (torque seal) to all bolt heads (upper and lower hinges) (Fig.18).

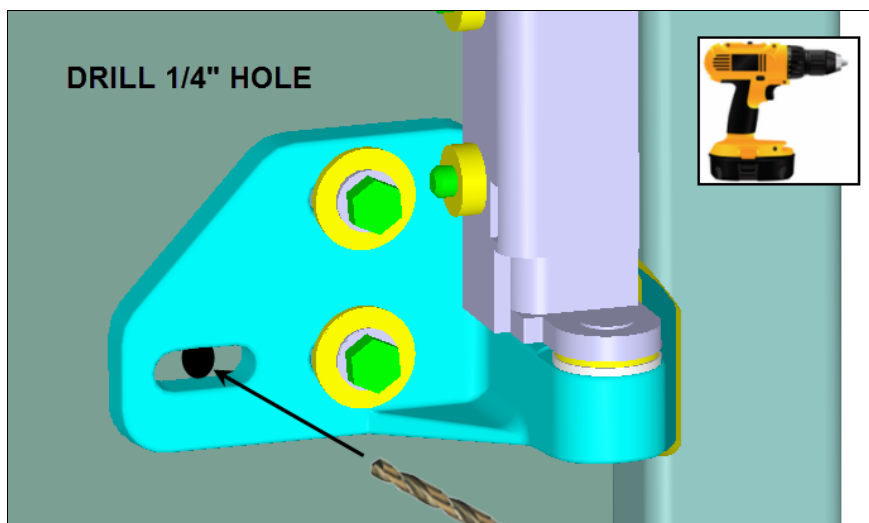
FIG.19 LOWER HINGE 3<sup>rd</sup> BOLT HOLE

8. Drill a 1/4" hole in the middle of the lower hinge 3<sup>rd</sup> slot (Fig.19).

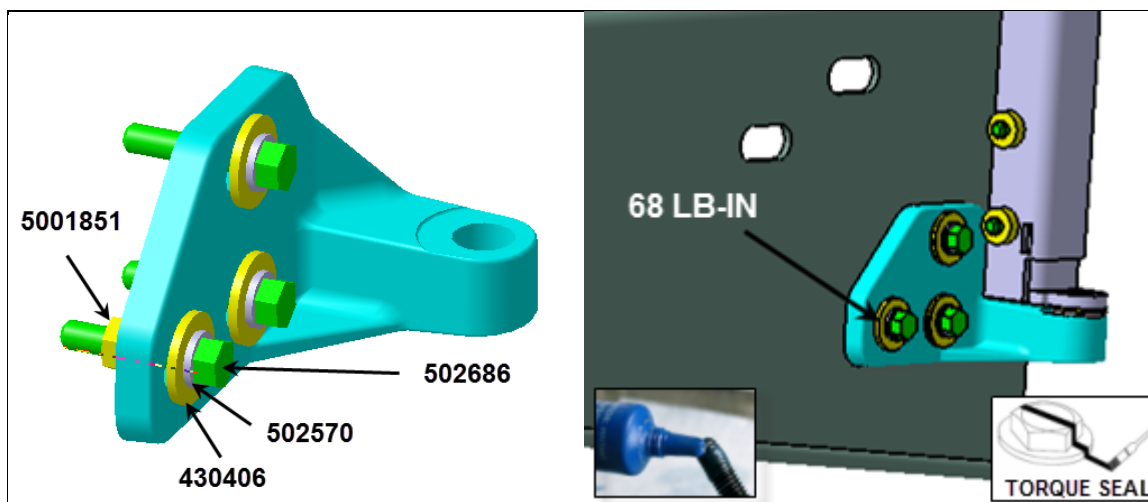
FIG.20 LOWER HINGE BOLT INSTALLATION & TIGHTENING TORQUE

9. Install the supplied bolt **502686**, nut **500851**, washer **430406** and lock washer **502570** in the previously drilled hole, Apply medium strength threadlocker and torque to **68 lb-in**. Apply a stripe of tamper proof indicator paint (torque seal) to the bolt head (Fig.20).
