MODEL
**2018MY
Rio (SC)**

NUMBER
PS529

SUBJECT: TPMS AND/OR TRUNK OPEN LAMP ON DURING PDI

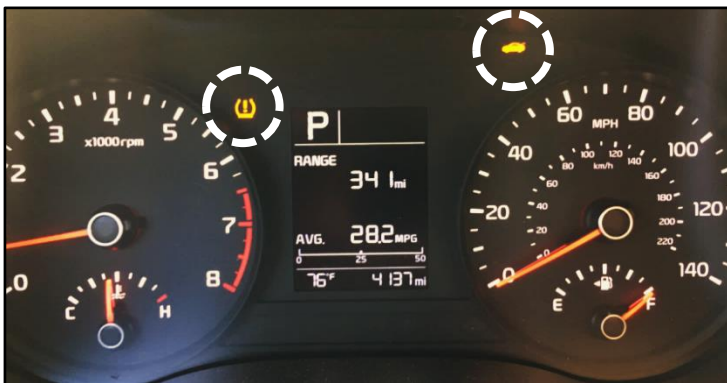
Type A cluster.

This Pitstop contains information regarding the TPMS lamp ON and Trunk Open warning lamp ON, or Master Warning Mode lamp ON in the cluster during PDI, even while the trunk is closed. This condition may be caused by the Transportation Fuse being in the OFF position.

Verify that the transportation fuse is ON (this can be done by ensuring the yellow transportation fuse tab holder is fully pressed into the In-Panel Junction Box, located in the lower driver's side crash pad) and that neither the AUDIO (A) nor ROOM (B) fuses are blown.
