MODEL: Karma Revero**DATE:** November 2017**TITLE:** Audio Amplifier Replacement**Revised** 11-30-17**APPLICABILITY:** MY17 and MY18 Revero (See attached Vin List)**MARKET REGION:** North America**PURPOSE:** Replacement of central channel audio amplifier

CC-17-94-24

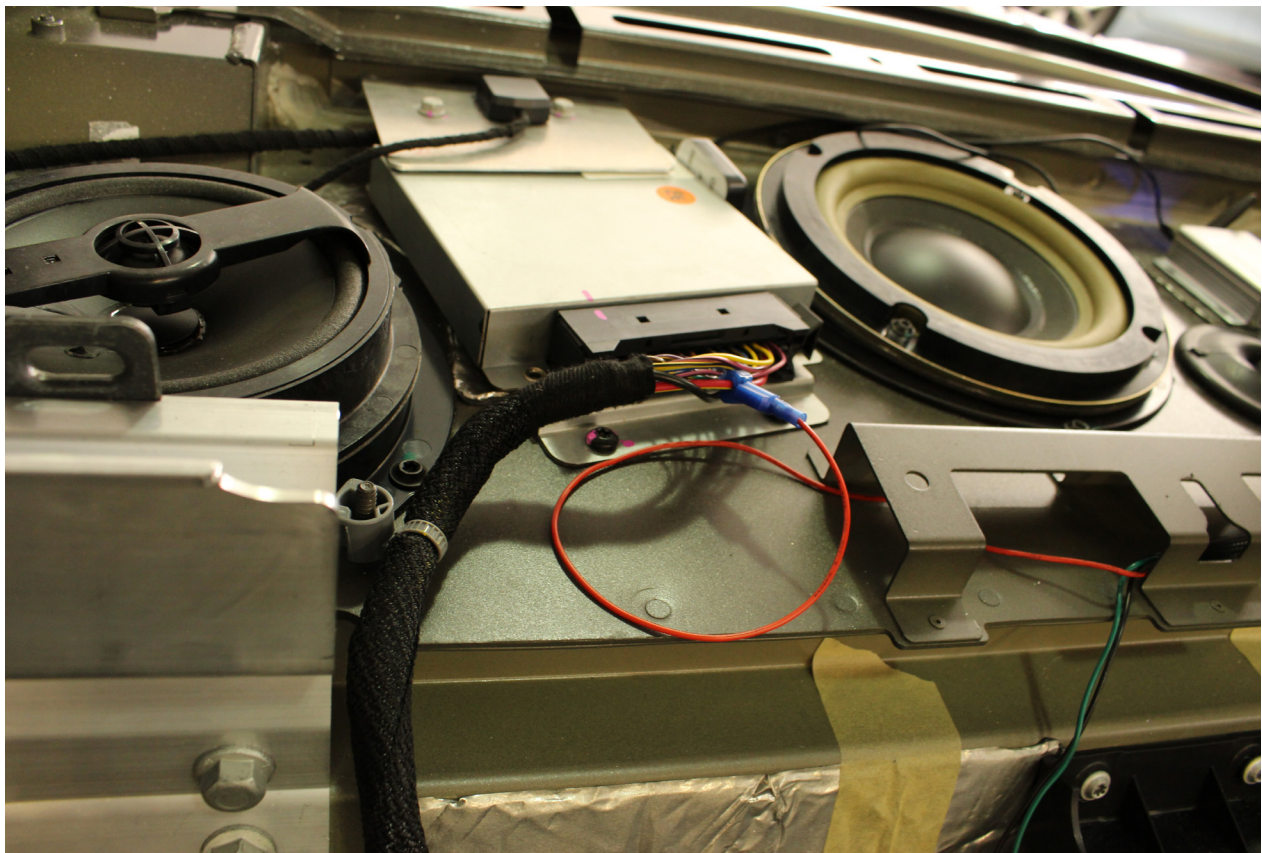
**fig.1a**

Located on the rear shelf, under the package tray, the central amplifier should be replaced with the latest version C131181200303 (fig 1a). A VIN list is provided on next page.

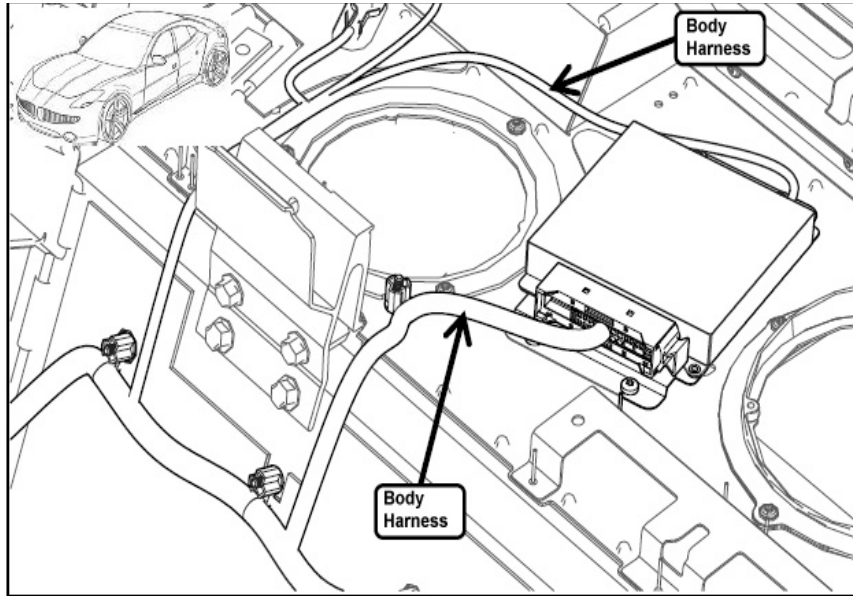
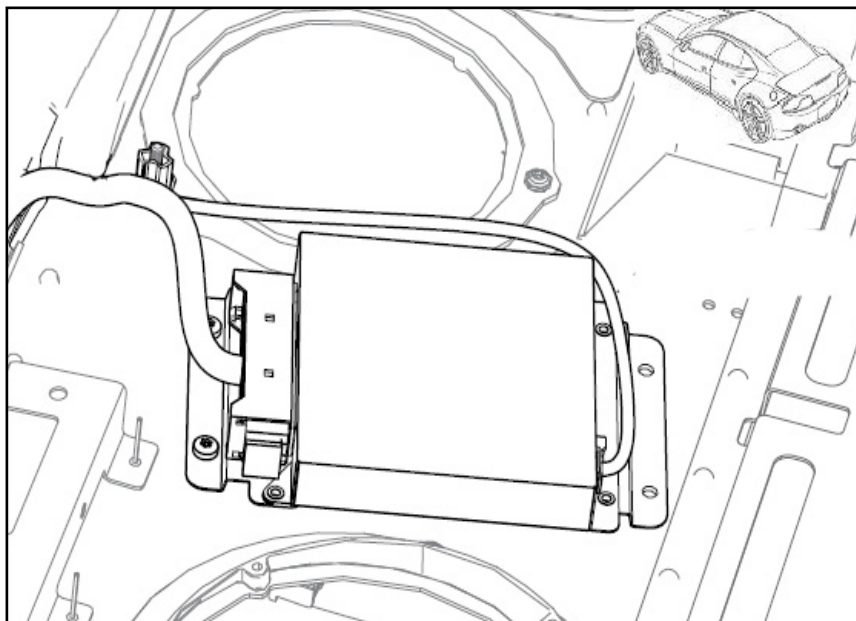
Note the body harness routing to avoid pinching or damaging it on reinstallation (Fig 2a and 2b).
