# Technical Bulletin

Model(s)	Year	Eng. Code	Trans. Code	VIN Range From	VIN Range To
e-Golf	2016	All	All	AU_GW906050	AU_GW916377

**93 17 02** August 17, 2017 **2047631** Supersedes Technical Bulletin 93-17-01 (V931701) dated May 18, 2017 to correct battery charge labor operation number in the warranty table.

### High Voltage Battery Charge Management - Charging Stops, Cannot Charge Battery

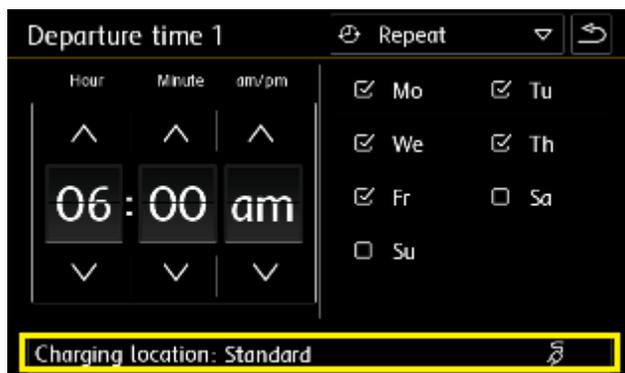
No departure time should be checked

- In departure time settings screen, select the charging location.
- No departure time settings are needed.
