MODEL
2017MY
Optima (JFa)
Sorento (UMa)
Optima Hybrid (JF HEV)
Optima Plug-in Hybrid (JF PHEV)

NUMBER
072A

TECHNICAL SERVICE BULLETIN

SUBJECT: SERVICE ACTION: INHIBITOR SWITCH
REPLACEMENT (SA317A)

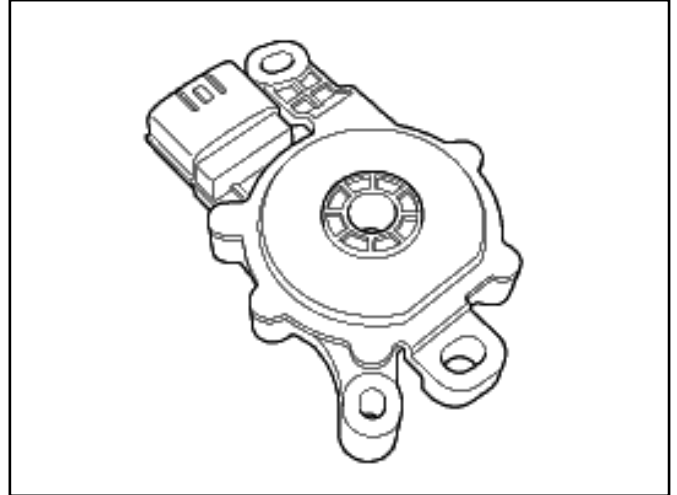
- Malfunction Indicator Lamp (MIL) on with DTC P0705 - Transmission Range Sensor (TRS) Circuit Malfunction (active or history)
- CAN-related DTCs (For both Hybrids: CAN DTC C2243)
- Intermittent no crank/no start
- Erratic or harsh shifting
- EPB and Hold lights illuminated intermittently
- Slight engine stumble when placed into Park ('P') position after a long drive
- No "Key OFF" indicated after placing the selector lever into the 'P' position and depressing the Start/Stop button. Note: When this condition occurs, the 'P' position is not indicated on the instrument cluster.

1. Replace the inhibitor switch by referring to the “Automatic Transaxle System → Automatic Transaxle Control System → Inhibitor Switch → Repair procedures” chapter of the applicable Shop Manual on KGIS.

2. Clear any related DTCs if necessary.
3. Confirm proper operation of vehicle.
