HYUNDAI Technical Service Bulletin	GROUP CAMPAIGN	NUMBER 17-01-069
	DATE DECEMBER, 2017	MODEL(S) SONATA 2.4L (LFa)
SUBJECT: A/C BRACKET BOLT INSTALLATION (SERVICE CAMPAIGN T2O)

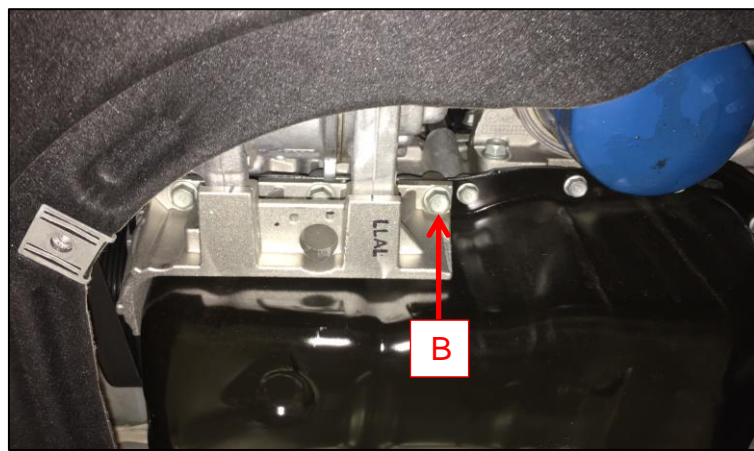
Description: Some Sonata 2.4L (LFa) vehicles may have an A/C bracket bolt missing. Prolonged use under this condition may result in bracket damage.

2. Install the missing A/C bracket bolt (B). (If bolt already exists, then retighten.)
 - **Tightening torque: 23 Nm (17 lb-ft)**
