HYUNDAI Technical Service Bulletin	GROUP BODY ELECTRICAL	NUMBER 17-BE-017
	DATE DECEMBER, 2017	MODEL(S) SONATA (LF) TUCSON (TL)
SUBJECT: AVN 4.0 APPLE CARPLAY PHONE CALL ECHO DEFECT

Applicable Vehicles:	<ul style="list-style-type: none"> • 2016MY Sonata (LF) equipped with AVN 4.0 • 2016MY Tucson (TL) equipped with AVN 4.0
-----------------------------	--

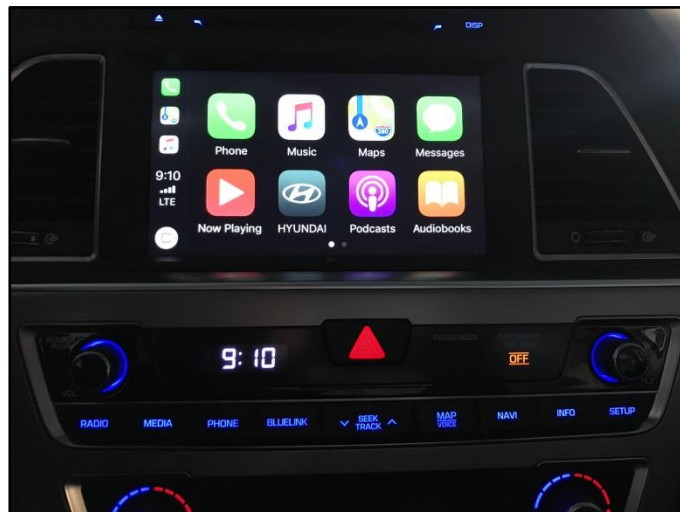
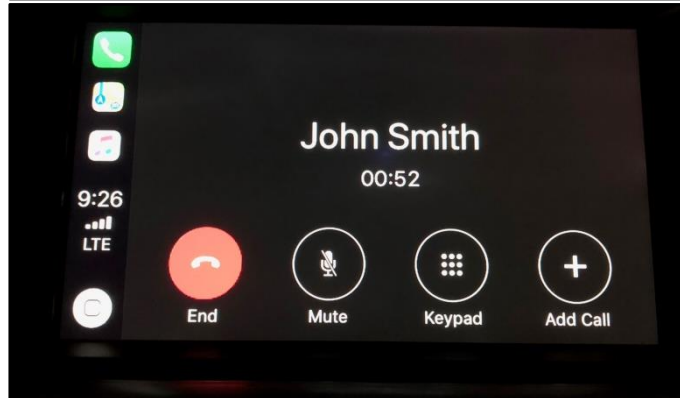
- 3. Once Apple CarPlay is open on the head unit display, place a phone call on your Apple device.

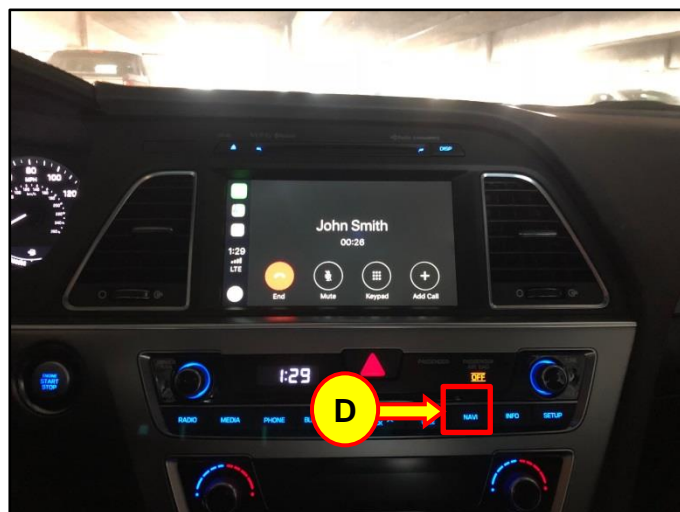
- 4. While on the phone call, press the “NAV” (D) Button.

NOTICE
If after pressing the “NAV” button an echo is heard on the call, then a head unit replacement is needed.
