# HYUNDAI Technical Service Bulletin

NUMBER  
17-01-059-1

MODEL(S)  
ELANTRA (AD)

**SUBJECT:** CONSOLE ARMREST COVER INSPECTION AND REPLACEMENT  
(SERVICE CAMPAIGN T2I)

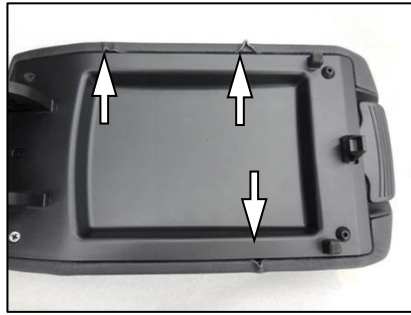
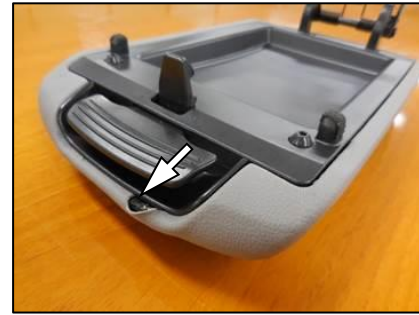
**Description:** This bulletin describes the procedure to inspect and replace the floor console armrest if the cover material is found to be peeling.

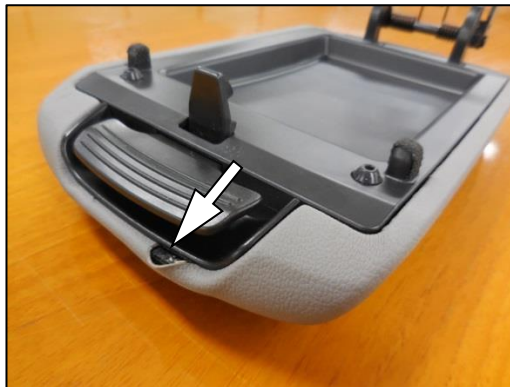
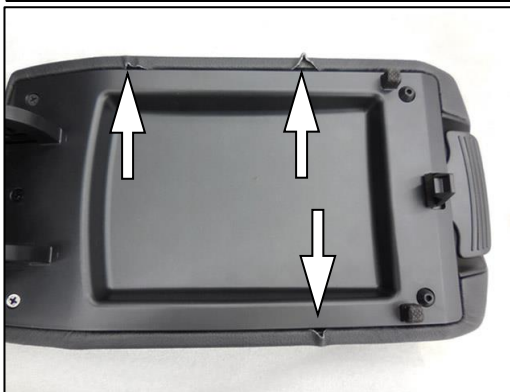
1. Open the floor console armrest cover. Visually inspect the underside for material peeling as shown.

Note: The arrows point to examples of peeling material.

- 1) If the cover material is found to be OK (material is tightly attached to the housing), no further service procedure is required. **Use Labor Op Code: 70C077R0.**
- 2) If the cover material is found to be peeling similar to what is shown in the pictures, replace the console armrest with a new one according to the procedure below.
