Technical Service Bulletin

GROUP CAMPAIGN	NUMBER 17-01-045-2
DATE DECEMBER, 2017	MODEL SONATA (LF HEV/ LF PHEV)

SUBJECT: HYBRID STARTER GENERATOR (HSG) INSPECTION / REPLACEMENT
(Service Campaign T2E)

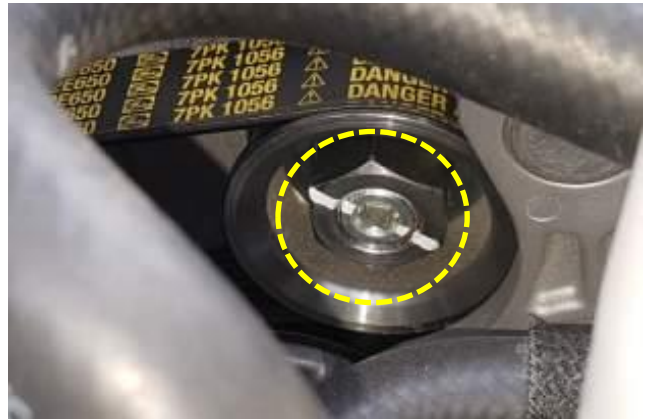
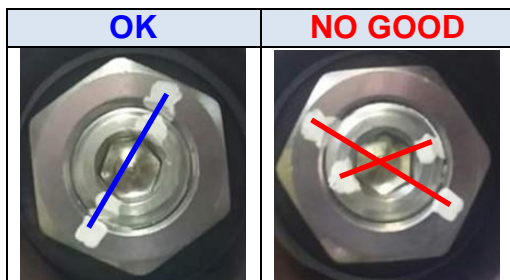
2. Inspect the HSG pulley nut to determine whether the paint marks line up between the nut and bolt.

Based on the above nut rotation state:

- **OK** - TSB service is complete. (OP CODE : 70C001R1)
- **NO GOOD** - Proceed to the next page **Section-C. HSG REPLACEMENT**

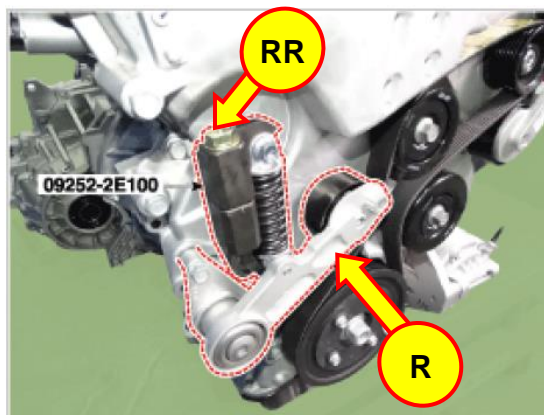
- Install one of the TENSIONER SST (09252-2E100 or 09244-G2100 as listed on page-2) to the hydraulic tensioner (R) and then compress the hydraulic tensioner by tightening the adjusting bolt (RR).

To prevent damage to the hydraulic tensioner, slowly tighten the SST nut by hand. DO NOT use an impact wrench to tighten it.

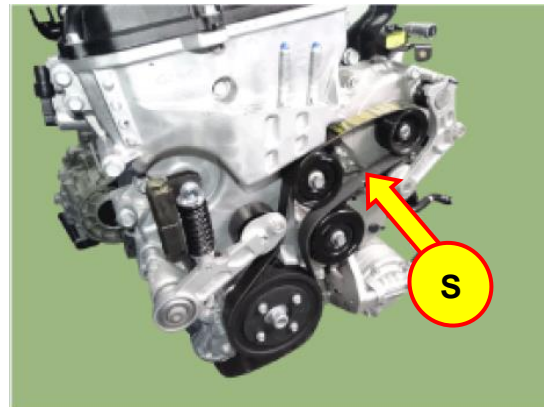
- While both tensioners are compressed, remove the drive belt (S) and inspect the belt.

Inspect the drive belt. Replace the belt if any chunks are found missing from the ribs. Cracks on rib side of the belt are OK.
