GROUP BOD	MODEL 2016MY Cadenza (VG)
	NUMBER 171	DATE December 2017
TECHNICAL SERVICE BULLETIN		
SUBJECT: CLUSTER FASCIA PANEL REPLACEMENT

SUBJECT: CLUSTER FASCIA PANEL REPLACEMENT

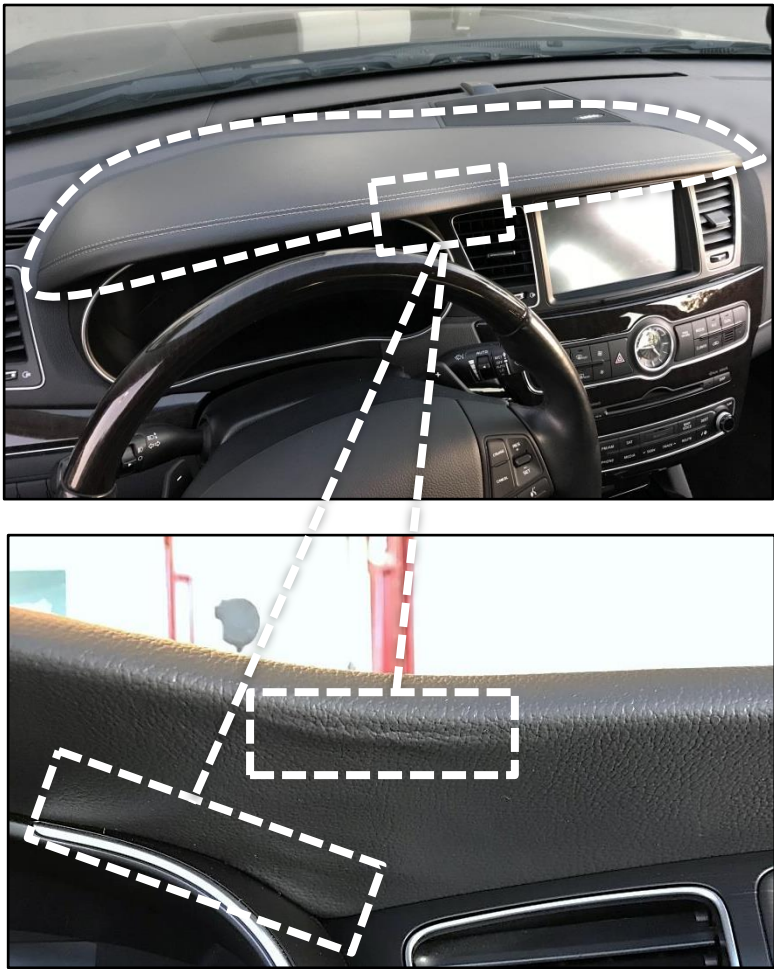
This bulletin provides information regarding the replacement of the cluster fascia panel on some 2016MY Cadenza vehicles, produced from March 16, 2015 through January 1, 2016, which may exhibit wrinkles or deformation. Follow the procedure outlined in this bulletin to replace the cluster fascia panel with an improved part.
