GROUP BOD	MODEL 2018MY Stinger (CK)
	NUMBER 178	DATE December 2017
TECHNICAL SERVICE BULLETIN		
SUBJECT: SERVICE ACTION: RATTLE NOISE FROM TAILGATE (SA322)

SERVICE ACTION: RATTLE NOISE FROM TAILGATE (SA322)

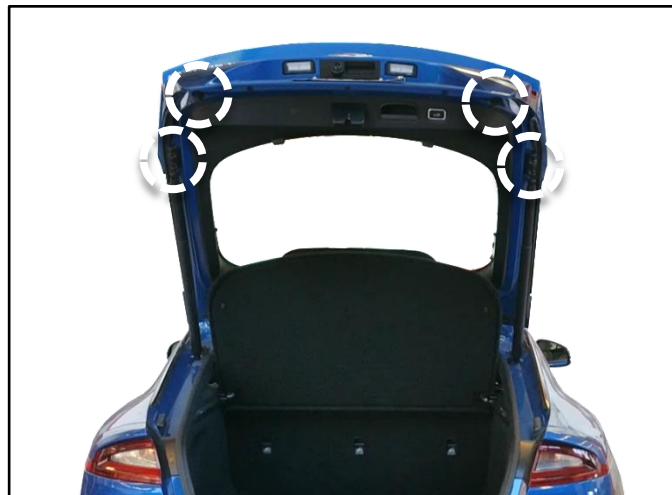
This bulletin provides the procedure to adjust the overslam bumpers and install a guide bumper mounting kit on some 2018MY Stinger (CK) vehicles, produced from September 21, 2017 through November 14, 2017, which may exhibit a rattle noise while driving, especially over bumps. Follow the procedure outlined in this bulletin to adjust the overslam bumpers and install a guide bumper mounting kit. Before conducting the procedure, verify that the vehicle is included in the list of affected VINs.
