MODEL
2014MY
Forte (YD)

NUMBER
082

TECHNICAL SERVICE BULLETIN

SUBJECT: FRONT WHEEL HUB BEARING AND
CASTLE NUTS REPLACEMENT

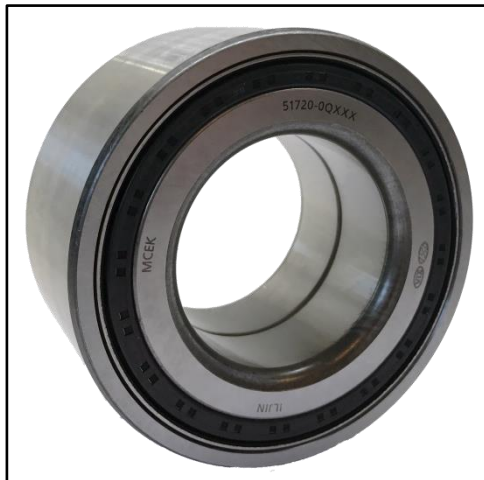
Front Wheel Hub Bearing

This bulletin provides the procedure to replace the front wheel hub bearing and both front castle nuts on some 2014MY Forte (YD) vehicles, produced from February 18, 2013 through February 5, 2014, which may experience abnormal noise from the front wheel hub bearing area while driving. Follow the procedure outlined in this bulletin to replace the affected front wheel hub bearing and both front castle nuts with improved parts. The improved castle nut collar is thicker and threaded at the staking section.

1. Replace the affected front wheel hub bearing (A) and both front castle nuts* (B) with the improved parts by referring to the “Driveshaft and axle → Front Axle Assembly → Front Hub / Knuckle → Repair procedures” chapter in the applicable Shop Manual on KGIS.
