## INSTRUCTION TO SERVICE

**ITS: 6722**

| <b>SUBJECT:</b> | "NABI" – MGM E-Stroke Harnesses |

# ITS6722

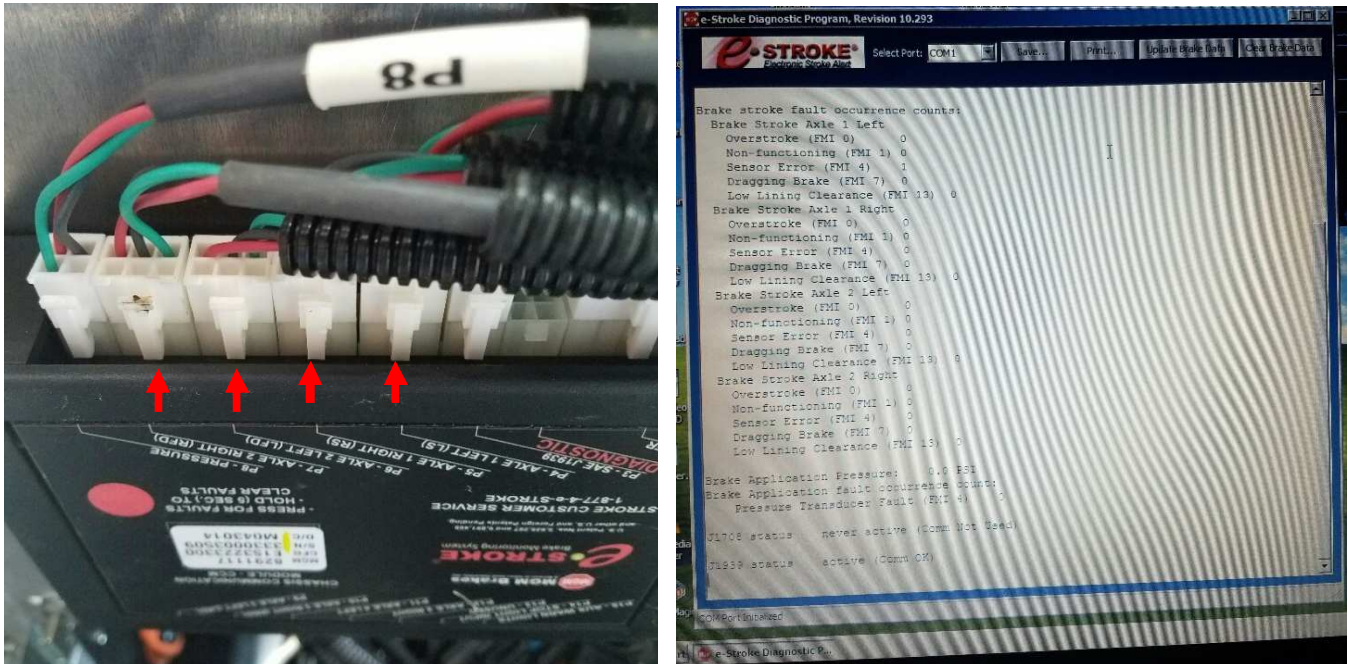
**Issue:** MGM E-stroke system may miss wired.

**Figure 3: The four harnesses that need to be disconnected / checked – Gen 3 version is shown**

4. To verify that the harnesses coming from the brake chambers are connected to the matching ports on the CCM, unplug harnesses one by one and verify that the error message on the laptop screen is matching the harness. For example when the harness labeled “RR” (Right Rear) is disconnected the error message should appear beside the “Axle 2 Right” on the screen. If required, swap harnesses to match the correct ports on the CCM. Refer to Figure 3.

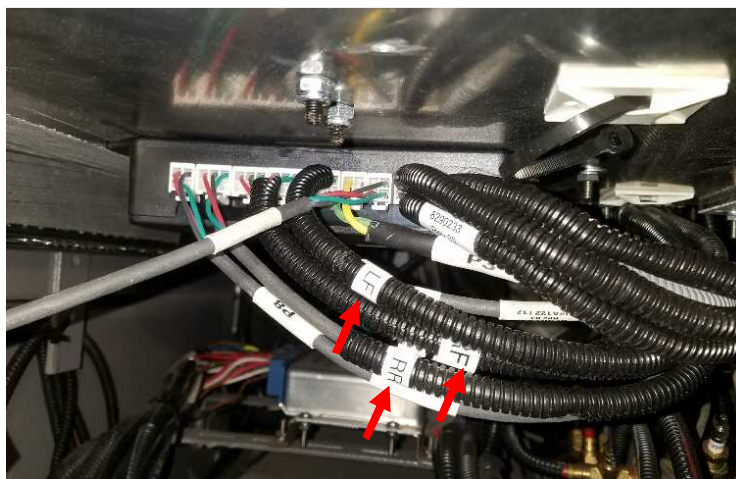
**Figure 4: Labels on harnesses**

5. If harnesses have no identification and/or they are miss labeled then remove incorrect label and install a new piece of tape (masking tape, electric tape or similar) and write the correct location the harness is coming from (RR, LR, RF or LF). Refer to Figure 4.
