MODEL: Karma Revero**DATE:** December 2017**TITLE:** Front Door Glass Fitment Inspection and Adjustment**First Release****PRIORITY:** On Complaint**APPLICABILITY:** MY17 and MY18 Revero**MARKET REGION:** North America**PURPOSE:** Remedy for possible wind noise complaint

Technical Service Bulletin

TB-17-76-21

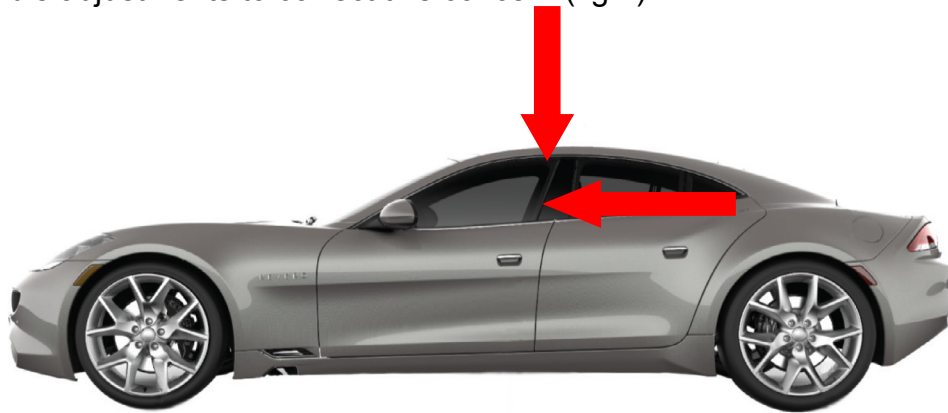
fig 1

The front door glass may not sit flush at the DLO and B-pillar location. The following procedure is to highlight the possible adjustments to correct this concern (fig 1).

1. Verify condition of window glass, it must sit flush against the seals on the body when in the full up position and the door closed. The gap to appliqué should be 10 to 11.5mm and parallel along the glass edge.

Adjustment requires the glass clamp screws to be loosened, glass adjusted and re-tightened to 10Nm.

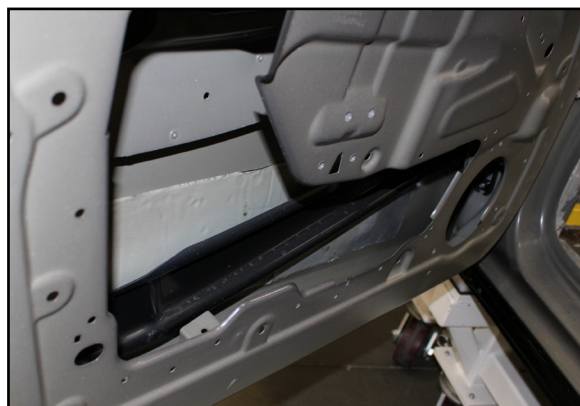
fig 7

Shown here is a door without regulator or harnesses to highlight the interior parts (fig 7).
There should be no rattles when the door is closed or slammed with the glass up and glass down.
