JTBO0547NAS3

**TECHNICAL BULLETIN**

204-01: Front Suspension

Anti-lock Braking System Warning Lamp Illuminated in Instrument Cluster

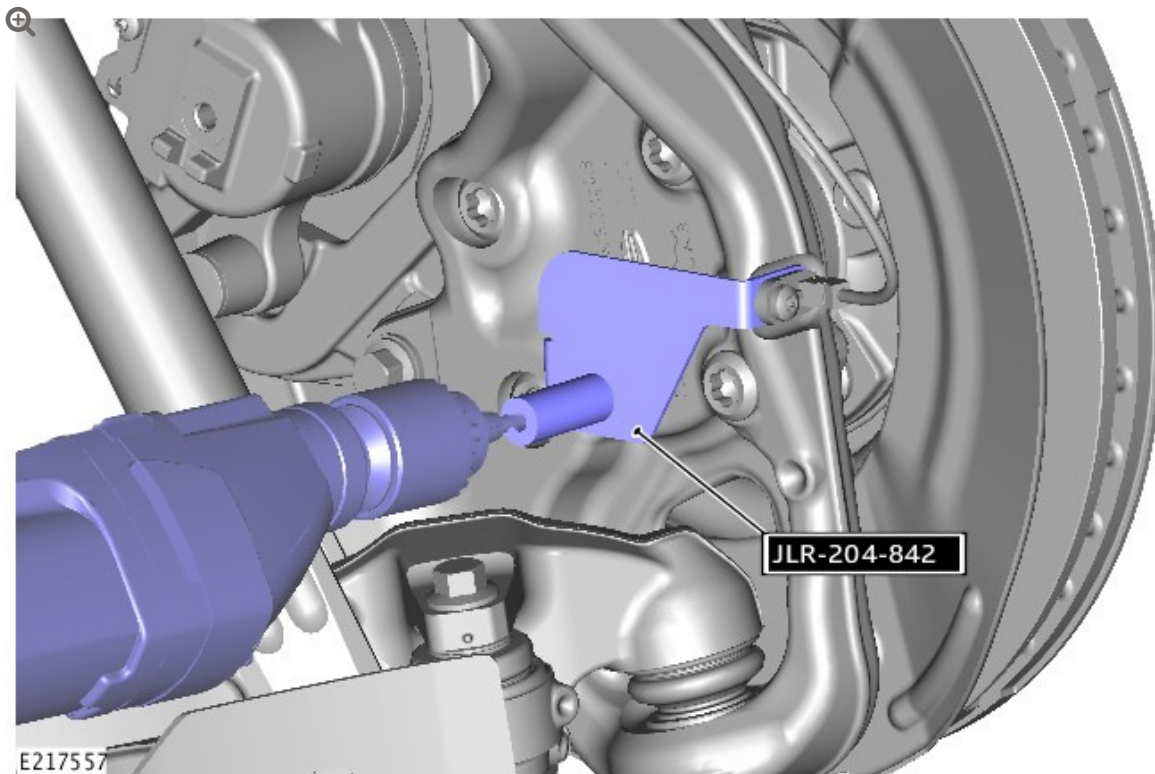
7

This may be caused by water ingress through the wheel speed sensor mounting location.

Using JLR-204-842 as a guide, drill a hole in the wheel knuckle.
