# Technical Journal

TITLE:  
**Sensus Navigation. IAM 2.1 software upgrade to allow map upgrade via USB**

<b>REF NO:</b> TJ 31762.4.0	<b>ISSUING DEPARTMENT:</b> Technical Service	<b>CAR MARKET:</b> United States and Canada	
<b>PARTNER:</b> 3 US 7510 Volvo Car USA		<b>ISSUE DATE:</b> 2017-06-16	<b>STATUS DATE:</b> 2017-06-27
<b>FUNC GROUP:</b> 3972	<b>FUNC DESC:</b> Road navigation	Page 1 of 5

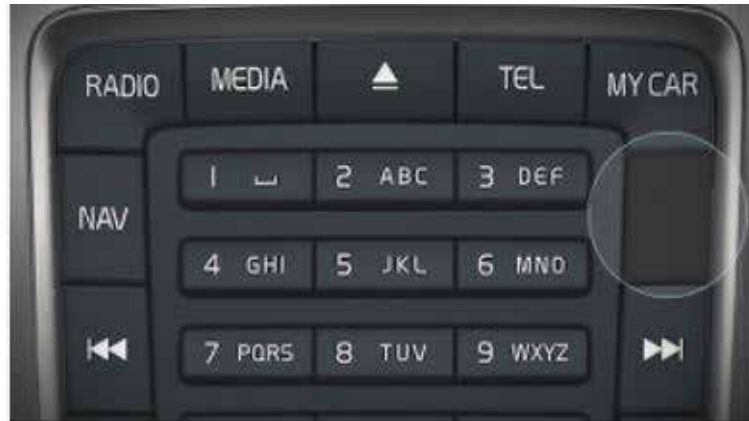
File Name	File Size
SENSUS RTI IAM.JPG	0.0195 MB

Map updates for Sensus navigation systems in MY2011-2015A cars (identified as shown in attached picture) can now be downloaded online and transferred to the car via a USB flash drive in the same way as current models.
