# Technical Service Bulletin

| <b>Technical Service Bulletin:</b><br>TSB140017 | <b>Released Date:</b> 16-Nov-2017 |

## Breather Filter and Crankcase Tube Freezing Issue in Below Freezing Temperatures

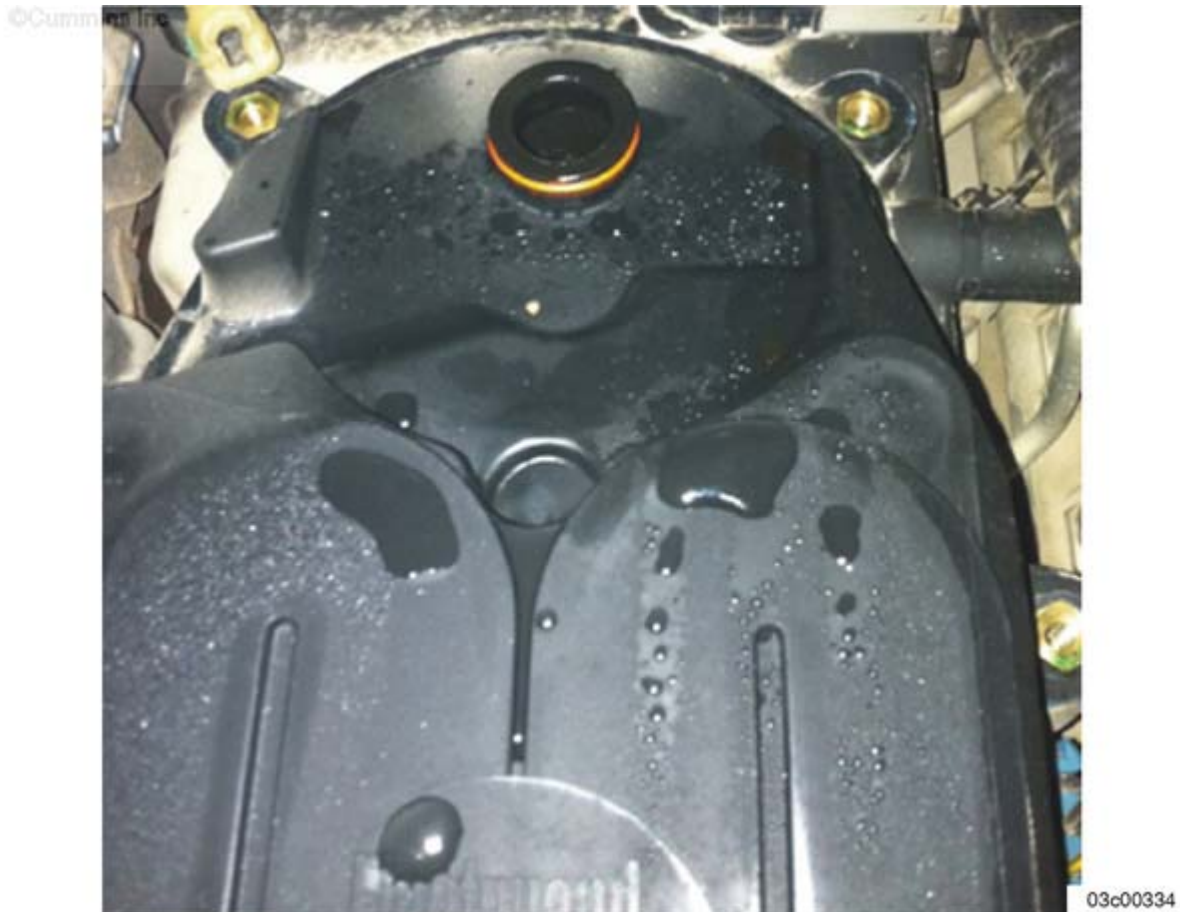
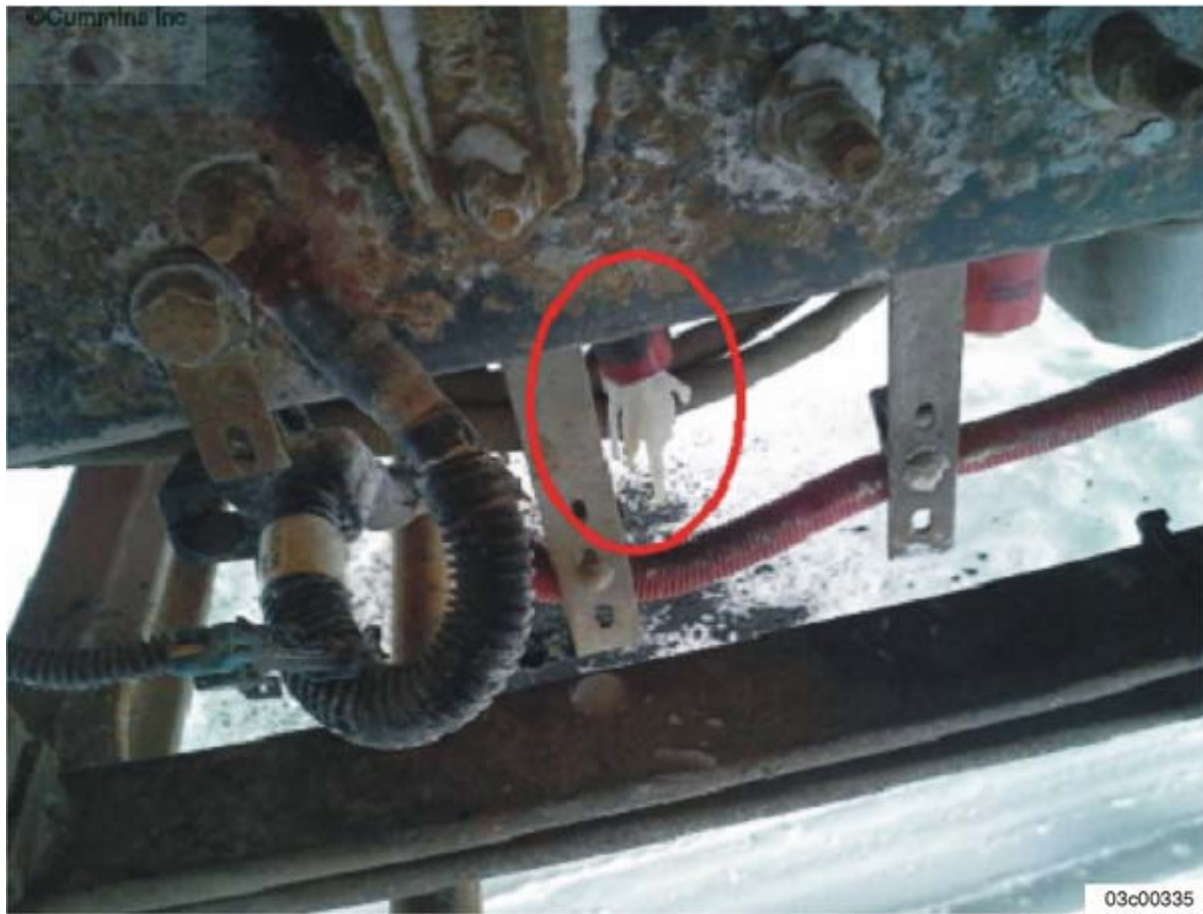
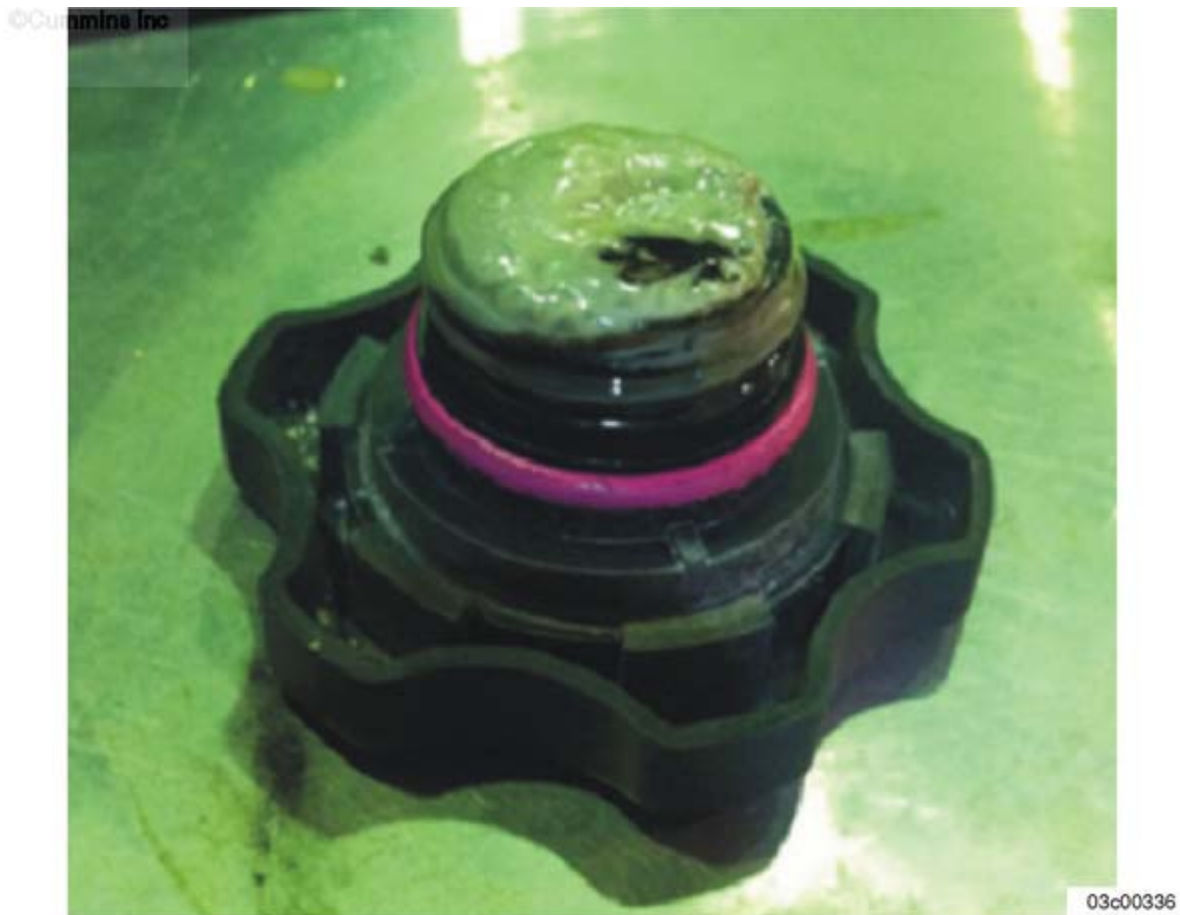
The crankcase breather filter and crankcase tube freezing could cause crankcase pressure to build, resulting in:

- Lubricating oil leaks at the turbocharger seal, valve cover gasket, and rocker housing gasket or front or rear crankshaft seals.
- Logging high crankcase pressure Fault Codes 555 and 556.

If these symptoms and fault codes are observed along with below freezing temperatures, check the breather filter and crankcase tube for freezing. Photographs are shown below for reference. Condensation might be observed on the breather element.

If the breather filter and/or crankcase tube is found to be plugged by icing, install the cold weather upfit kit, Part Number 5314954. Reference Service Bulletin 4908173 for detailed installation instructions. This kit contains two heaters that will keep the filter and tube from freezing in below freezing temperatures. This upfit kit is **not** covered by warranty.
