# Technical Service Bulletin

| <b>Technical Service Bulletin:</b><br>TSB170119 | <b>Released Date:</b> 28-Nov-2017 |
| <b>Charging System Alternator Bracket Malfunction: IC Bus CE Series</b> | |

## Charging System Alternator Bracket Malfunction: IC Bus CE Series

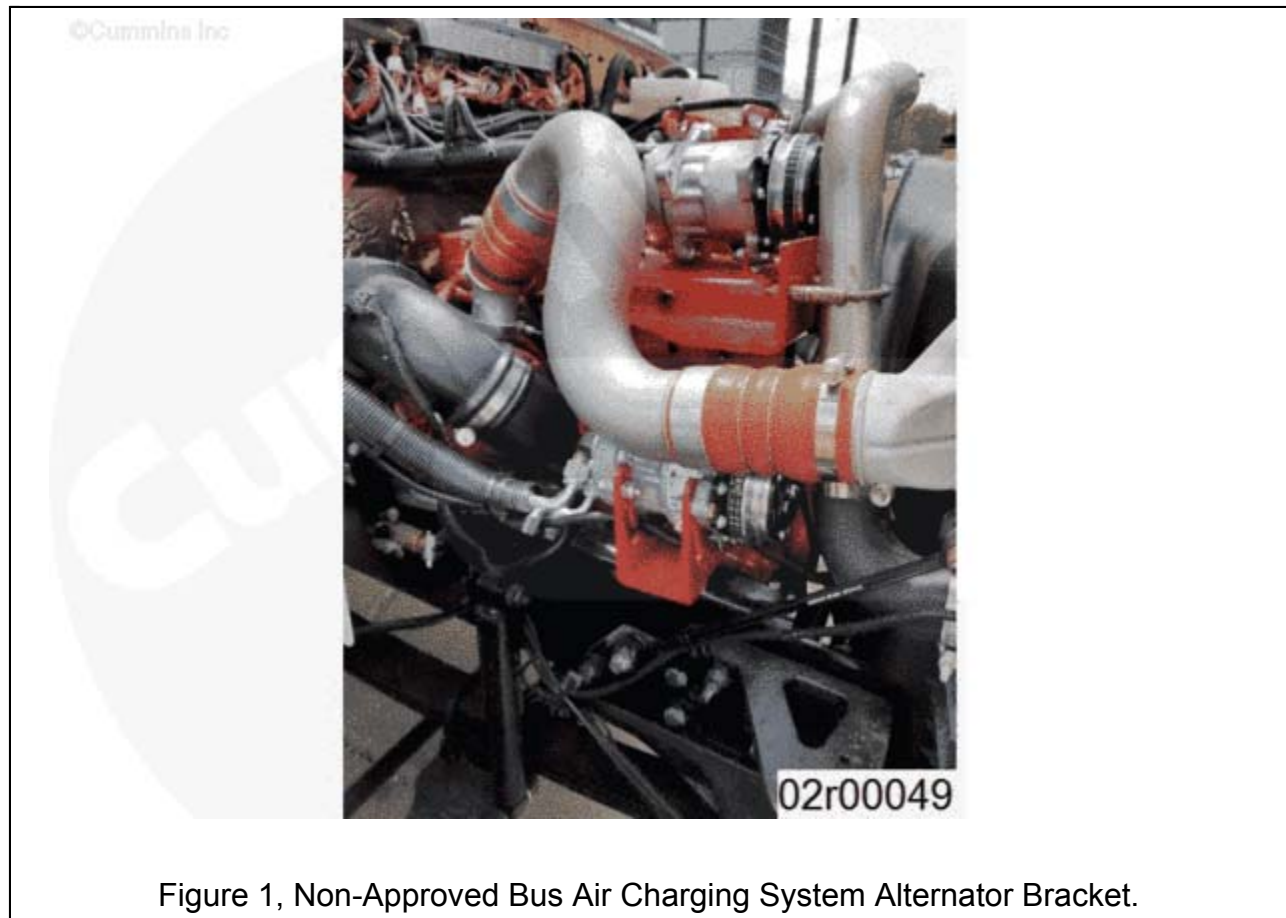
- Use of non-approved Dual Freon™ compressor system installed by Bus Air.
- IC Bus utilizes a Navistar approved bracket painted black.
- Bus Air utilizes a non-approved bracket painted red. See Figure 1 below.

- Any malfunctions, as outlined in this document, associated with the installation of a non-approved charging system alternator bracket are **not** covered under Cummins® warranty.
- Repair locations are to contact their nearest Bus Air representative for repair guidance.

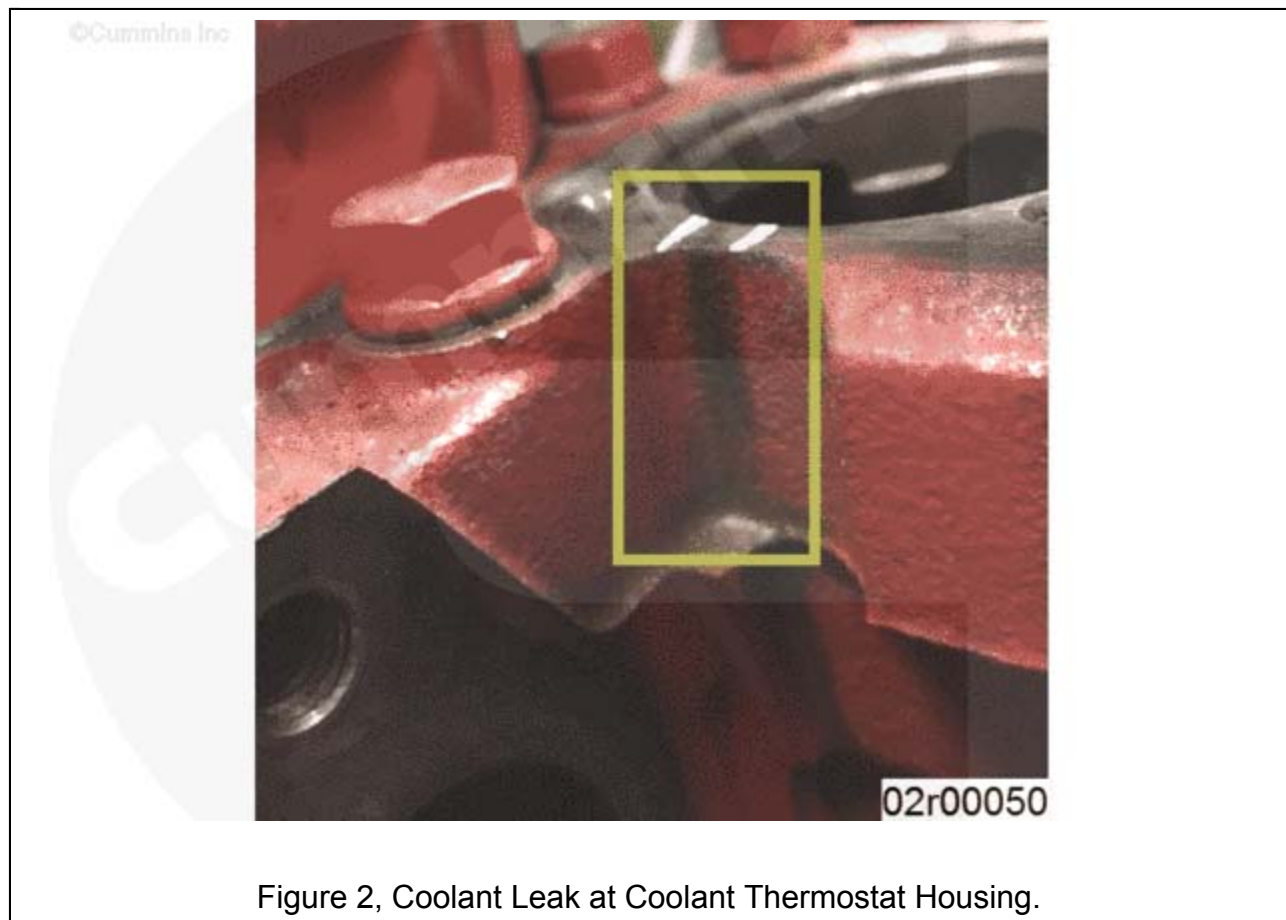
- Broken or cracked Bus Air charging system alternator bracket. See Figure 6 below.
- Coolant leak at coolant thermostat housing. See Figure 2 below.
- Cylinder head cracking. See Figure 3 below.
- Bus Air contact information is located on passenger side of firewall. See Figure 4 below.
- Bus Air bracket on engine and off engine, without dual Freon™ compressor, is shown in Figures 5 and 7 below.

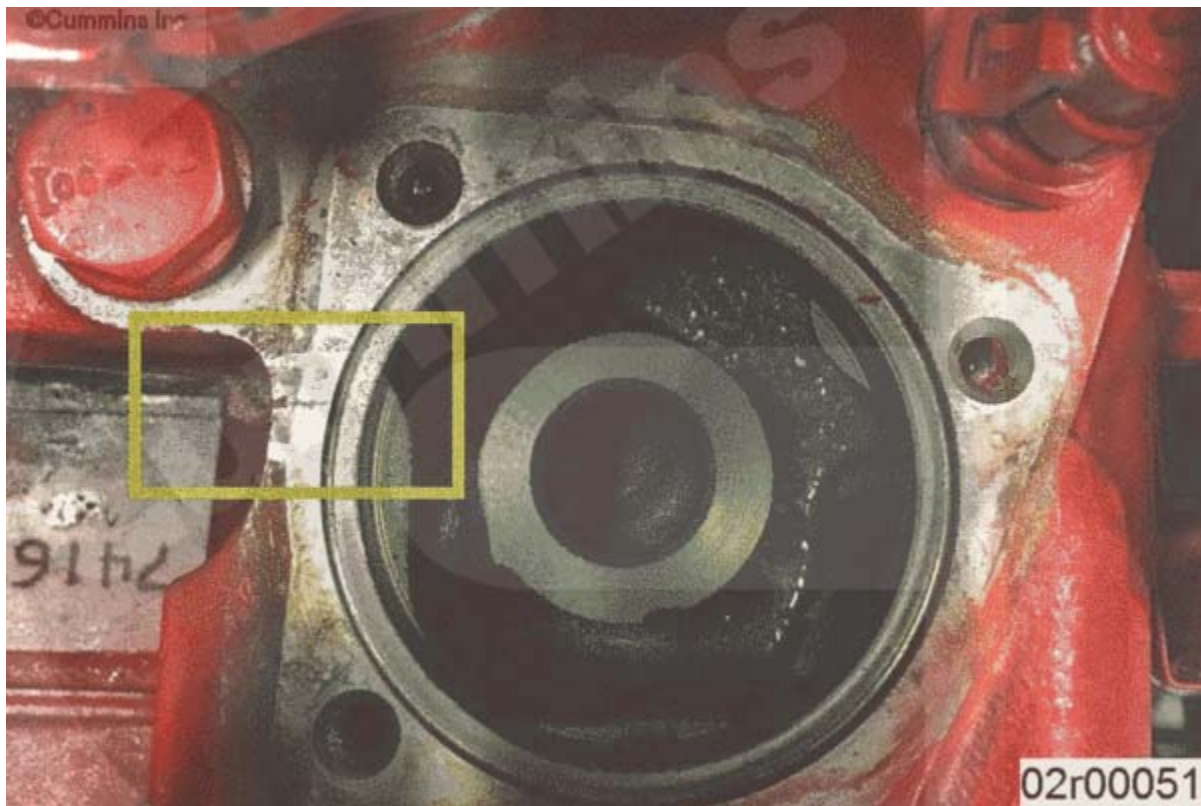
- Charging system alternator / Freon™ brackets are malfunctioning and can cause cracking to initiate near cylinder head coolant thermostat housing.

Figure 3, Cylinder Head Cracking at Coolant Thermostat Housing.

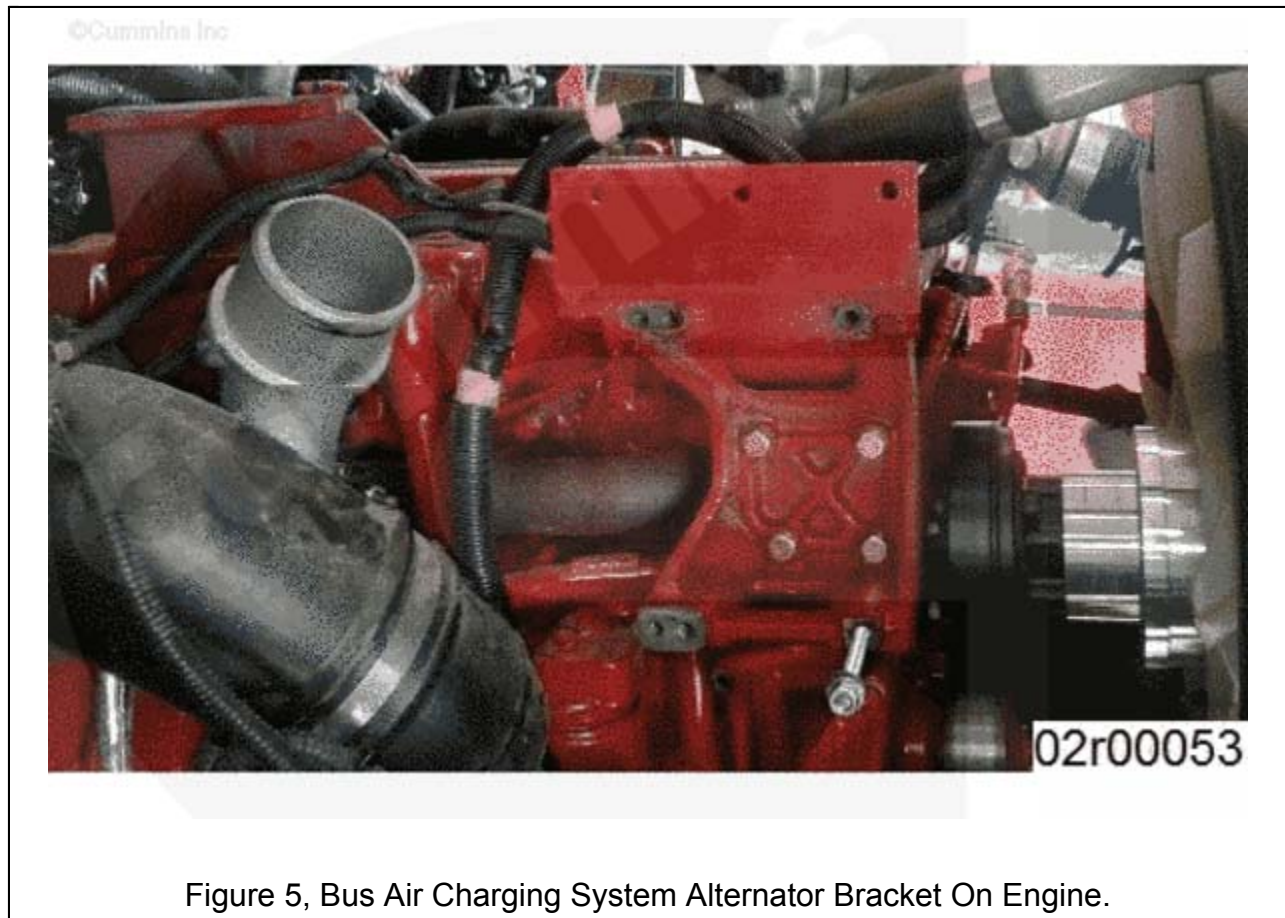
Figure 5, Bus Air Charging System Alternator Bracket On Engine.

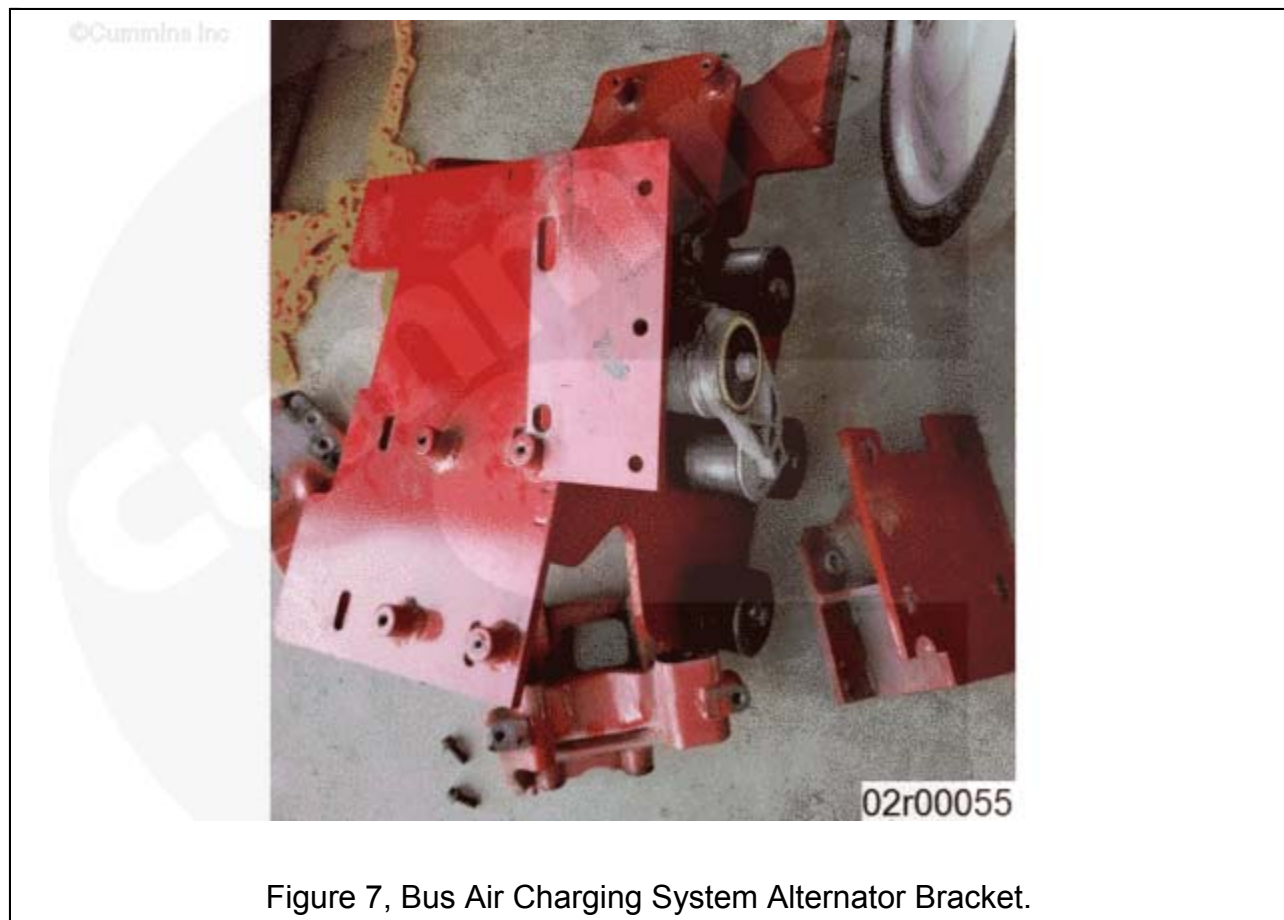
Figure 7, Bus Air Charging System Alternator Bracket.
