TECHNICAL SERVICE BULLETIN

Unintended Exterior Mirror Movement In Wet Weather Conditions - Moisture In Exterior Mirror Connector

17-2225

08 November
2017

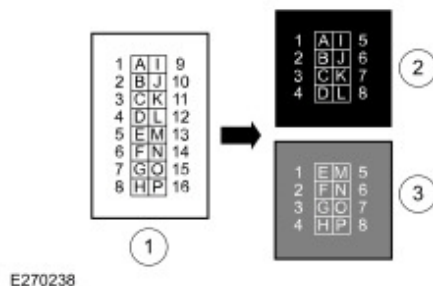
Figure 1

Issue: Some 2013-2014 Fusion and 2013-2018 MKZ vehicles may exhibit unintended exterior mirror movement in wet weather conditions due to moisture in the exterior mirror connector.

1. Remove the affected exterior mirror. Refer to WSM, Section 501-09.
2. Remove the original 16-pin mirror connector by cutting the wires 13 mm (1/2 inch) from the connector and splice to the 8-pin gray and 8-pin black male connector pigtails by following the wiring repair kit instructions included with the pigtail kit. (Figure 1 Connector Face)

3. Remove the original 16-pin door harness mirror connector by cutting the wires 13 mm (1/2 inch) from the connector and splice to the 8-pin gray and 8 pin black female connector pigtails by following the wiring repair kit instructions included with the pigtail kit. (Figure 1 Connector Face)
