## SERVICE BULLETIN

Classification: EC16-036b	Reference: NTB16-117b	Date: December 7, 2017
------------------------------	--------------------------	---------------------------

### 2016-2017 ALTIMA; MIL ON WITH A/F RATIO SENSOR DTC(s)

**APPLIED VEHICLE:** 2016-2017 Altima (L33)

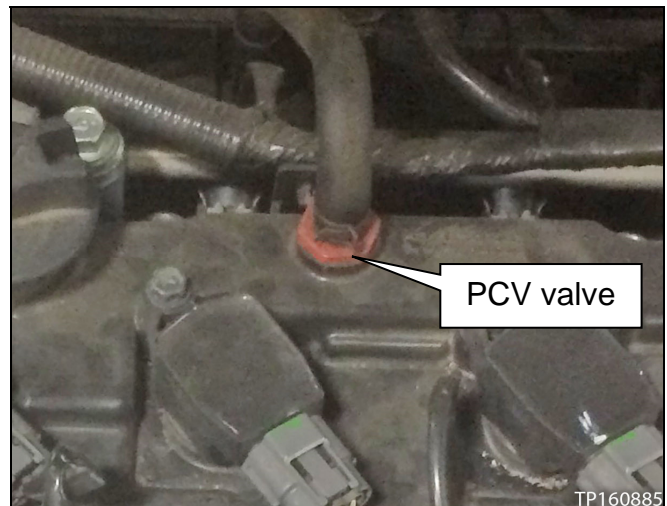
Figure 1

3. If the PCV valve is **orange** in color, replace it.

**NOTE:** The new PCV valve is **black** in color.

- The new PCV valve is listed in the **PARTS INFORMATION** section of this bulletin.
- Refer to the Electronic Service Manual (ESM), section **EC-Engine Control System**, for PCV valve replacement information.

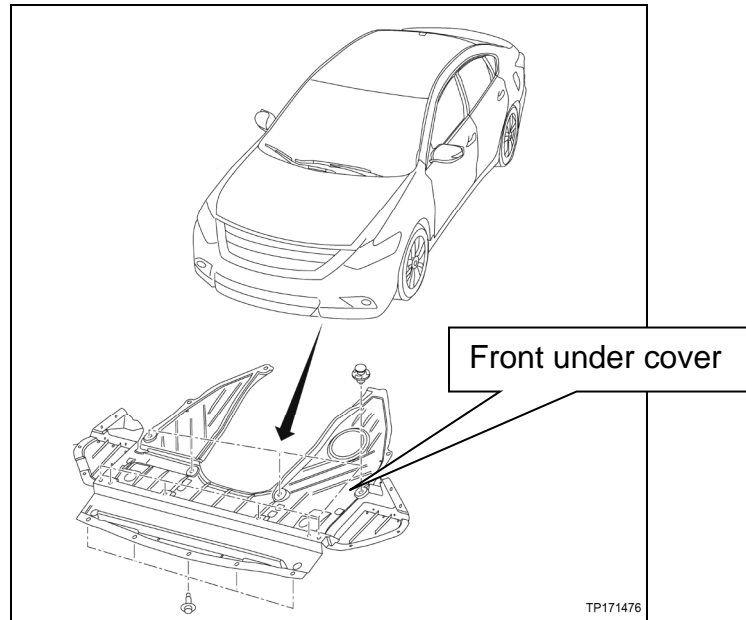
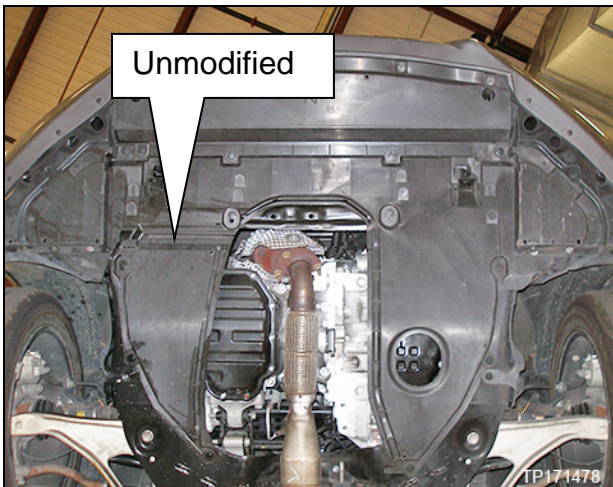
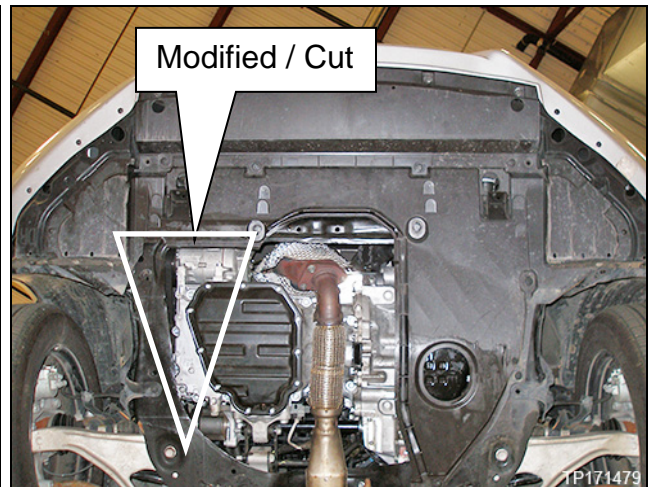
5. Inspect the front under cover for modifications.

6. Replace the front under cover if it has been modified / cut / broken.

- Refer to the Electronic Service Manual (ESM), section **EXT – Exterior / REMOVAL AND INSTALLATION / FRONT UNDER COVER / Removal and Installation**.

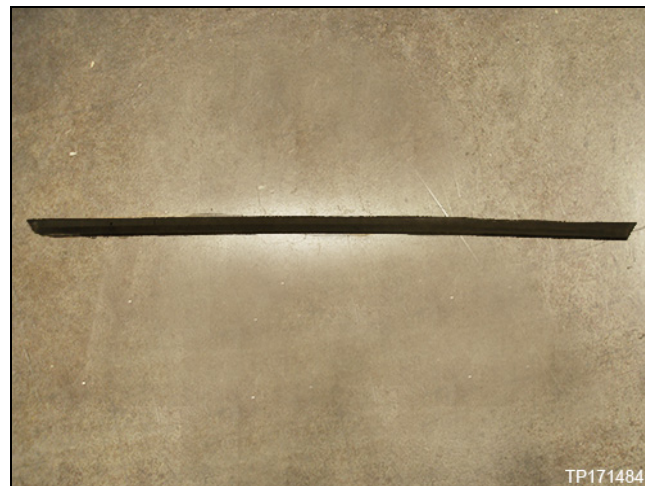
10. Figure 10 shows the grille shutter seal (upper) after being removed from the vehicle.
