23/14 ENU 2480

Eliminating Symptoms - Engine: Replacing Intake Manifold Pressure Sensor (Vehicle jerking while driving/SY2314)

Vehicle Type: 918 Spyder

Model Year: 2015

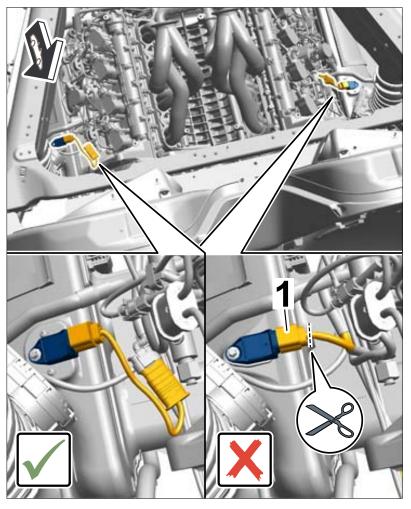
- 2.1 If the **adapter intermediate piece is already fitted** between the engine wire harness and intake manifold pressure sensor connector (⇒ *Figure 1* **Left**-)
  - $\Rightarrow$  Replace the **existing adapter intermediate pieces with the adapter cables** (variant a Part No.: 918.607.105.00 Adapter with cable 2 required) **and replace the intake manifold pressure sensors**.

- 2.2 If there is **no adapter intermediate piece** between the engine wire harness and intake manifold pressure sensor connector (⇒ *Figure 1* **Right**-)

The engine wire harness connector (⇒ *Figure 1* **Posi. 1**-) is secured directly to the intake manifold pressure sensor connector.
  - ⇒ The engine wire harness connector must be reworked:

- 2.2.1 Disconnect engine wire harness connector from the cable (⇒ Figure 1 Use wire cutters Pos. 1-) and crimp the new connector with new contacts and single-wire seals (variant b Part No. of set: 918.607.913.00 2 required) to the engine wire harness.
- 2.2.2 Repeat Step  $\Rightarrow$  2.2.1 on the other cylinder bank.
- 3 Install exhaust system, see Workshop Manual ⇒ Workshop Manual '260119 Removing and installing exhaust system', section on "Installing exhaust system" and "Subsequent work".
