WH56 - Reworking Fastening Screw for Engine Ground Cable on Front Right Longitudinal Member (Workshop Campaign)

Model Line: **Panamera (971)**

Model Year: **As of 2017 up to 2018**

Subject: **Fastening screw for engine ground cable on front right longitudinal member**

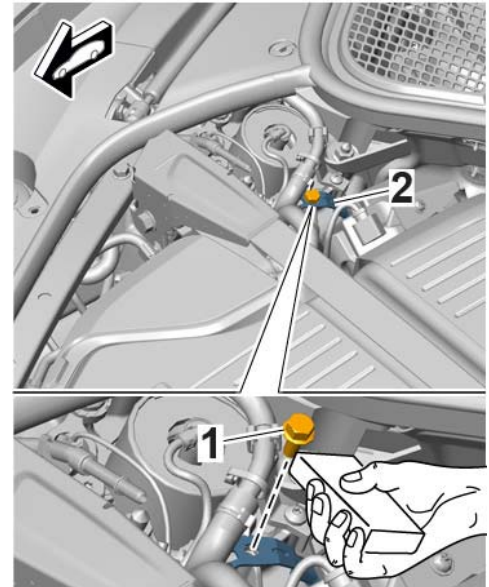
Fastening screw for ground cable

Concern: **There is a possibility that the fastening screw for the engine ground cable on the front right longitudinal member may not have been tightened sufficiently.**

As a result, the tightening torque of the threaded connection may be further reduced with increasing vehicle mileage. This can cause sporadic electrical faults with corresponding error messages displayed in the instrument cluster and fault entries in the fault memory.

- 3 Unscrew fastening screw \Rightarrow *Fastening screw for ground cable -1-* and clean the contact surface on the body, screw head and ground cable \Rightarrow *Fastening screw for ground cable -2-* using sandpaper.
- 4 Secure ground cable \Rightarrow *Fastening screw for ground cable -2-* on the longitudinal member again using the fastening screw \Rightarrow *Fastening screw for ground cable -1-*. **Tightening torque 20 Nm (15 ftlb.)**
- 5 Close front hood.
- 6 Enter the campaign in the Warranty and Maintenance booklet.
