Tail Light Defective Warning in the Instrument Cluster

Binder - Advanced Technical Information

Vehicle Type: **All Cayenne (92A) Models**

Model Year: **2015 - 2016**

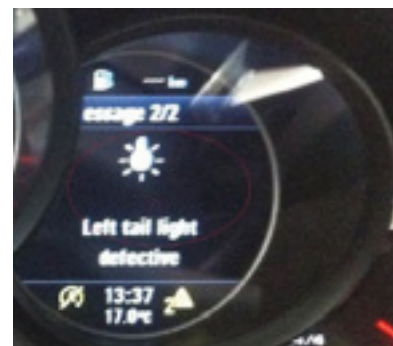
Figure 1

Customer Concern: The driver receives a warning message in the instrument cluster indicating that a tail light is not working (See Figure 1). Also, the driver will observe the turn signal indicator has an increased repetition rate, as if the light is not lighted. However, in some cases, the tail light actually does work as observed from outside the vehicle.

Technical Concern: The tail light produces a warning in the instrument cluster, indicating that the tail light is not working (See Figure 1). Also, one or more fault codes (880FOE or 880F1E) are observed in the Rear-End Electronics module using the PIWIS Tester. However, the tail light may be working.

Service Information: New guided fault finding is available in the PIWIS tester as of release 37.000. Consult this repair advice first.

The alternate solution is to replace at least one of the tail lights, based on these failure modes:

Case A) **False warning.** If the warning message is present and all the tail lights are lighted, the likely causative part is the outer tail light. Ensure that new part numbers from below are installed in the vehicle. Also, ensure that the inner tail lights have a production date after 5/20/2015, especially in cases where the new outer tail light part numbers were previously installed.

Case B) **Actual tail light outage.** If the warning is present and any of the tail lights are not lighted, replace that tail light as usual.
