JAGUAR LAND ROVER SHOP FOREMAN CONFERENCE CALL
NOVEMBER 9TH 2017

LOCAL TECHNICAL SUPPORT (LTS) NEWS & UPDATES

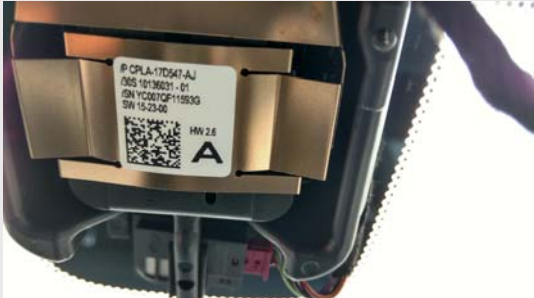
| Vehicle | Customer Concern | Details and Status | Publication |
|--|---|---|---|
| Vehicles Equipped with Head Up Display | Head Up Display dim in daylight | <p>Customers may report that the Head Up Display (HUD) is not visible during the daylight. Upon investigation through TA reports we have found the incorrect Rain/Light Sensor has been installed. Check the label on the lower right hand corner of the Rain/Light Sensor, A denotes non HUD and B denotes HUD. If you come across a vehicle with the incorrect sensor, please submit an EPQR with a photo of the Rain/Light Sensor label.</p> <p>- Non HUD Rain/Light Sensor</p> | To be released |

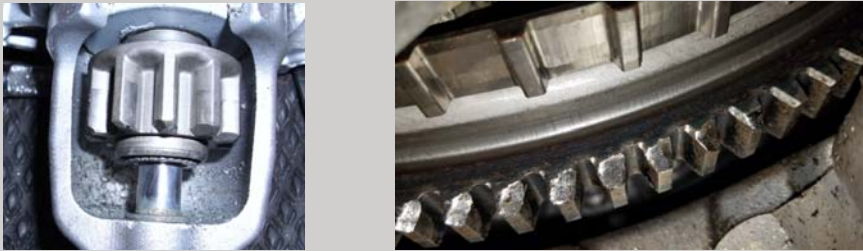
| Vehicle | Customer Concern | Details and Status | Publication |
|--|---|---|---|
| <p>Vehicles equipped with separate Starter Pinion and Starter Motor Relays</p> | <p>A customer may complain of a grinding noise when starting the vehicle.</p> | <p>Diagnosis may reveal wear on the flex plate (may not affect complete circumference). A possible cause for this complaint is the wiring for starter pinion circuit and starter motor circuit reversed. Compare the installation position including intermediate connectors in the circuit to the electrical diagram.</p> | <p>Under Investigation</p> |

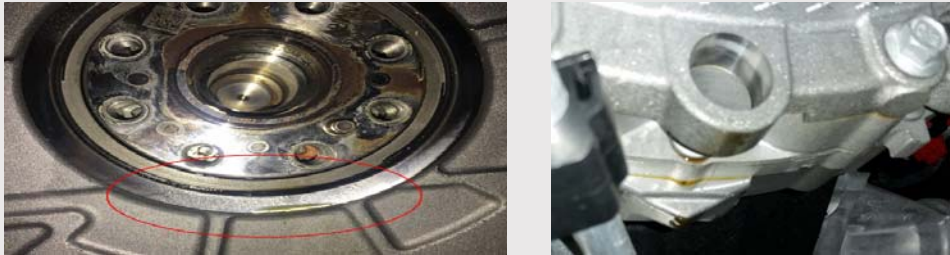
| Vehicle | Customer Concern | Details and Status | Publication |
|--|---|---|---|
| <p>18MY F-PACE RR Velar with 2.0L Petrol Engine</p> | <p>A customer may complain of an oil leak from the vehicle.</p> | <p>Inspect for evidence of a leak at the bottom of the bell housing. Use standard diagnostic procedures such as UV dye or leak trace powder to determine the source of the leak. If the leak is identified as coming from the rear main seal, raise an EPQR which includes pictures with the transmission removed.</p> | <p>Under Investigation</p> |

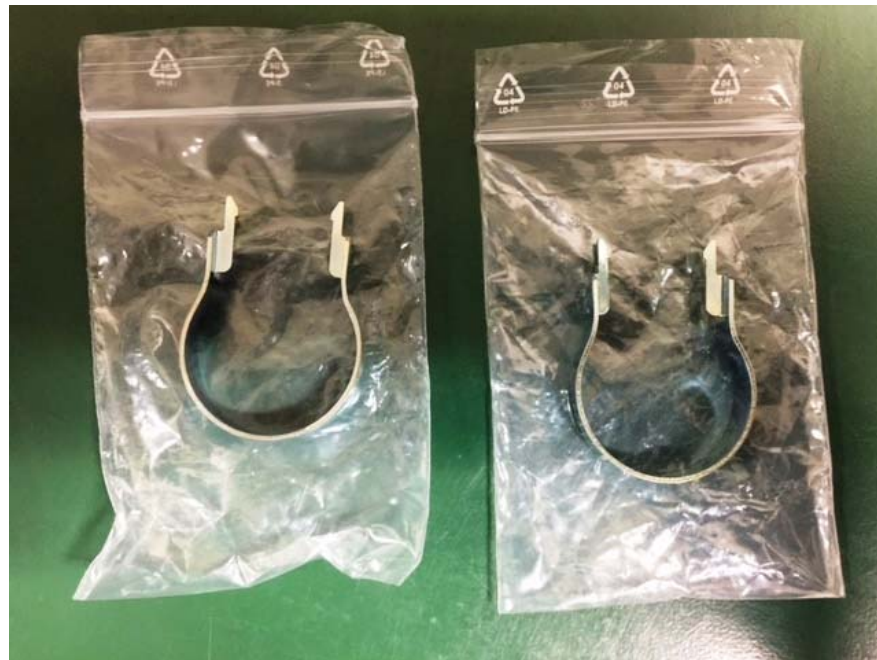
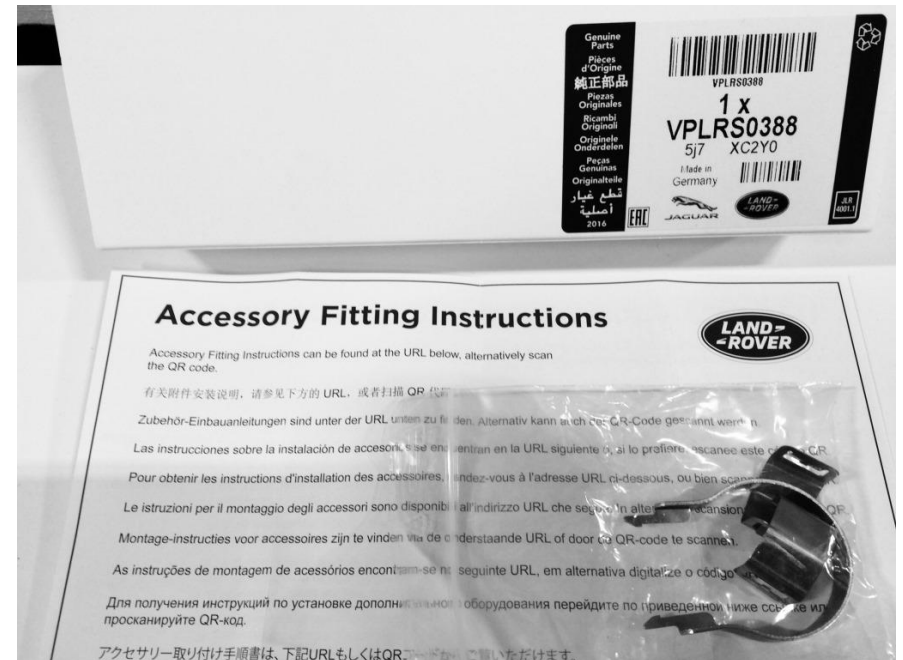
| Vehicle | Customer Concern | Details and Status | Raised By |
|---|---|---|---|
| RR Velar | Velar comes at PDI with two, small tools in a baggie in the center console or glove box that we can not identify what it is used for. | The tool pictured in the baggies are the removal tools for the spring clips that retain the accessory convenience pack base mounting bracket to the front seat headrest bars. The convenience pack consists of a coat hanger or hooks that are easily removed from the base bracket. Port fitted convenience packs will have these removal tools provided in the vehicle. | Mark Beaudrow Cole European |

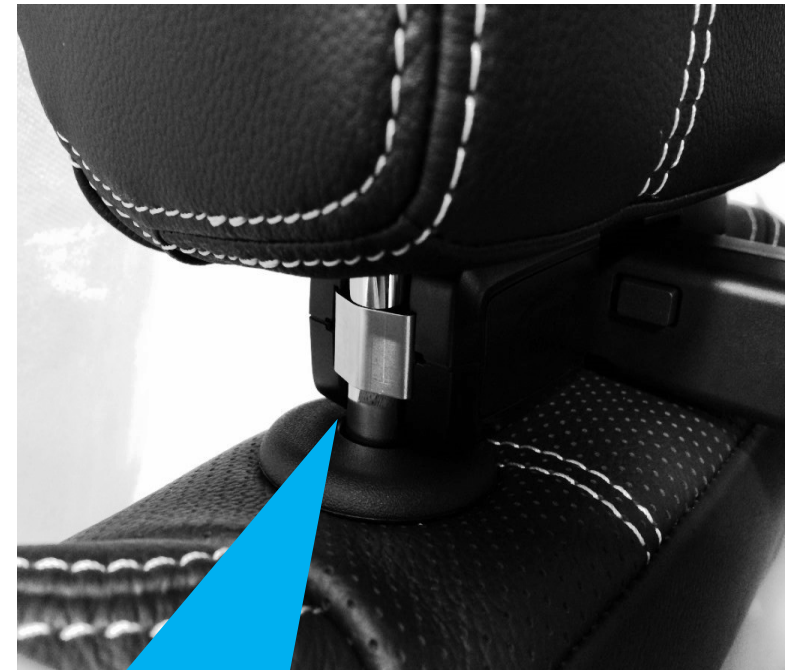
Spring retaining clip for convenience
pack base mounting
