Title (customer effect) Volvo Chassis - Equipped With Volvo Active Driver Assist (VADA) With Lane Departure Warning System (LDWS) - Safety Direct Processor (SDP) Fault Code MID 209 SPN 1705 FMI 5 Active Following OEM Radio Replacement With Aftermarket Part, Radio Mute Function Inoperative - US17 And Newer

Cause A Volvo Chassis - Equipped With Volvo Active Driver Assist (VADA) With Lane Departure Warning System (LDWS) may set Active Fault Code SPN 1705 FMI 5 in the Safety Direct Module (MID 209) if the OEM radio is replaced with an aftermarket head unit.

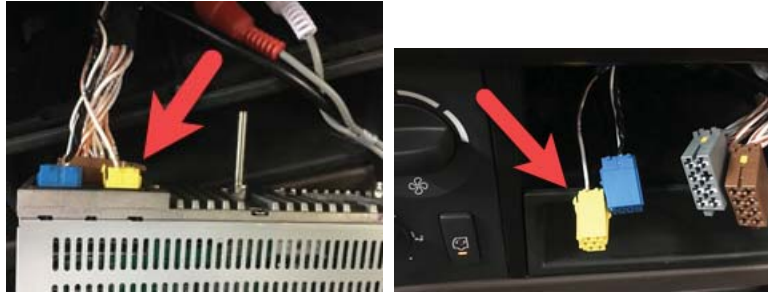
If the Radio Mute feature does not function following the repair:

A. The wire installed in the connector is the Radio Mute wire.

1. Locate the yellow connector that was plugged into the back of the OEM radio as shown below

2. The aftermarket radio documentation will need to be reviewed to verify if the radio supports a GND Mute input.

A. If the Mute input is supported, the wire will need to be connected to the correct wire or pin in the aftermarket pigtail (supplied with the radio) or connector
