DATE: 8-11-17

APPLIES TO: This service bulletin applies to 2017 – 2018 model year K2 model motor home chassis equipped with an Independent Front Suspension supplied by Reyco Granning built between January 17, 2016 and March 16, 2017.

CONDITION: Some bleeder assemblies may leak power steering fluid.

CORRECTION: Apply thread sealant.

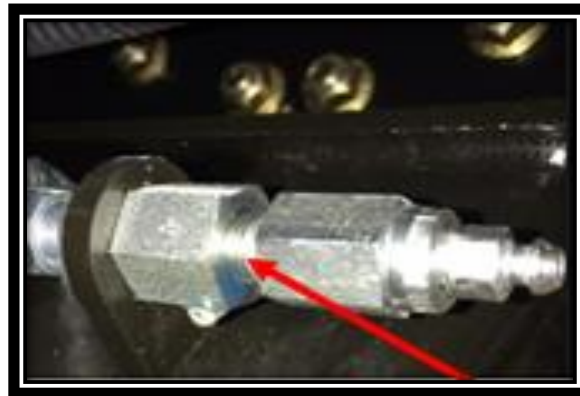
FIG. 2-1

Locate the steering bleeder assembly at front of cradle and inspect for thread sealant. Refer to FIG. 2-1.

1. If sealant is present and no leak is visible proceed to step 7.
2. If no sealant is visible or connection is leaking follow repair instructions below.
