# NEWMAR CORPORATION

## PRODUCT INFORMATION BULLETIN

| DATE ISSUED | MODEL YEAR(S) AFFECTED | PIB # |
|---|---|---|
| 12/27/17 | 2018 | 499 <b>Amended</b> |

KIB push-button compartment door lock modules on 2018 King Aire coaches may have a software glitch that may cause some modules to fail to automatically acquire their network ID when installed.

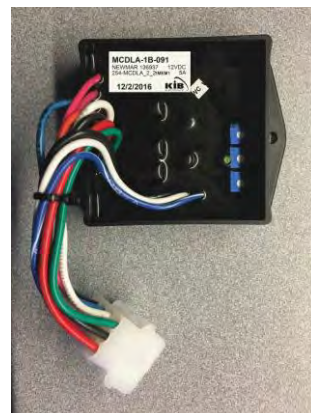
Fig.1

- Pick one of the two cargo doors with the issue.
- Locate the MCDLA-1B (Newmar Part#136937)
- Each cargo door has its own controller located behind that cargo door, usually mounted to upper subfloor.

- Unplug the 12-position connector.
- Unscrew MCDLA-1B from upper subfloor.
- Replace with new MCDLA-1B.
- Plug in the 12-position connector.
