Technical Service Bulletin

69 Airbag Light On (DTC B151329 Passenger Indicator Lamp Fault)

69 17 33 2047208/4 June 1, 2017. Supersedes Technical Service Bulletin Group 69 number 17-32 dated April 7, 2017 for reasons listed below.

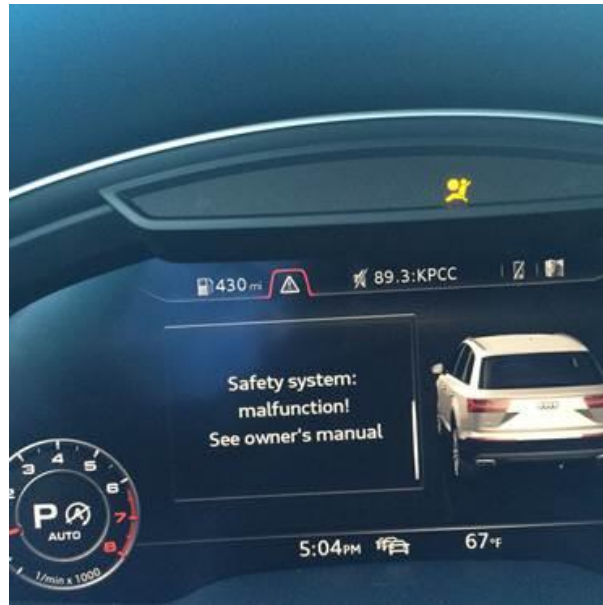
The airbag warning lamp will be illuminated in the cluster along with other warnings in the DIS (Driver Information System) (Figure 1). This concern only affects vehicles built after November 1st, 2016 as this is when the software level 103 was implemented into production.

This results in the fault to be stored in Airbag Control Module, J234 (address word 0015):

- **DTC B151329** Front passenger airbag indicator lamp, text lighting implausible signal passive/sporadic

Figure 1. Airbag warning lamp.

There is a communication fault with software level 103 in the J234 module. During the first few seconds of the vehicle self-check, when there is a change in the PODS classification from occupied to unoccupied and then back to occupied, this can cause a communication error between the J234 and K145 modules.

New software in the Airbag Control Module, J234 (address word 0015) addressed the condition.

1. Follow all instructions in TSB 2011732: *00 Software Version Management (SVM), operating instructions.*
2. Update the Airbag Control Module, J234 (address word 0015) using the SVM action code as listed in the table below if necessary:
