# Technical Service Bulletin

## 91 RMC: MMI display missing all text

91 17 30 2043595/3 June 7, 2017. Supersedes Technical Service Bulletin Group 91 number 16-89 dated November 14, 2016 for reasons listed below.

Model(s)	Year	VIN Range	Vehicle-Specific Equipment
A6	2014 - 2017	All	Radio low- NAR
Q3	2015 - 2017	All	Radio low- NAR

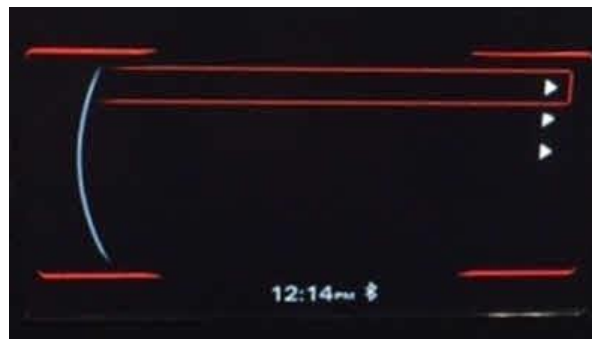
- The customer states that the display on the MMI screen is incomplete and text is missing (Figure 1 and Figure 2).
- Additionally, the cluster DIS text may be using an incorrect menu language.

Figure 1. MMI car menu missing text.

The RMC main unit is designed to support French, Spanish, and English languages. The control module software has an issue that can cause the system language to default to German. Because German is not contained in the software, the condition occurs.

- Contact TAC.
- If the menus change, then a hardware replacement is not needed. Perform a software update listed below:
- Update the RMC MMI software and complete the SVM code at the end of the process to code and parameterize the main unit and to provide feedback documentation to SVM. This process will also clear "Checking SVM DTC" if successful.

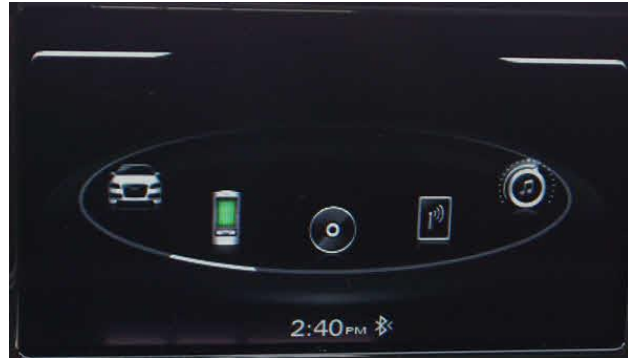
*Figure 2. MMI main menu missing text.*
